# CHASING GHOSTS

A GIS Analysis and Photographic Comparison of  
Vandalism and Site Degradation in Range Creek Canyon, Utah

2006

BLM Contract JMP052055

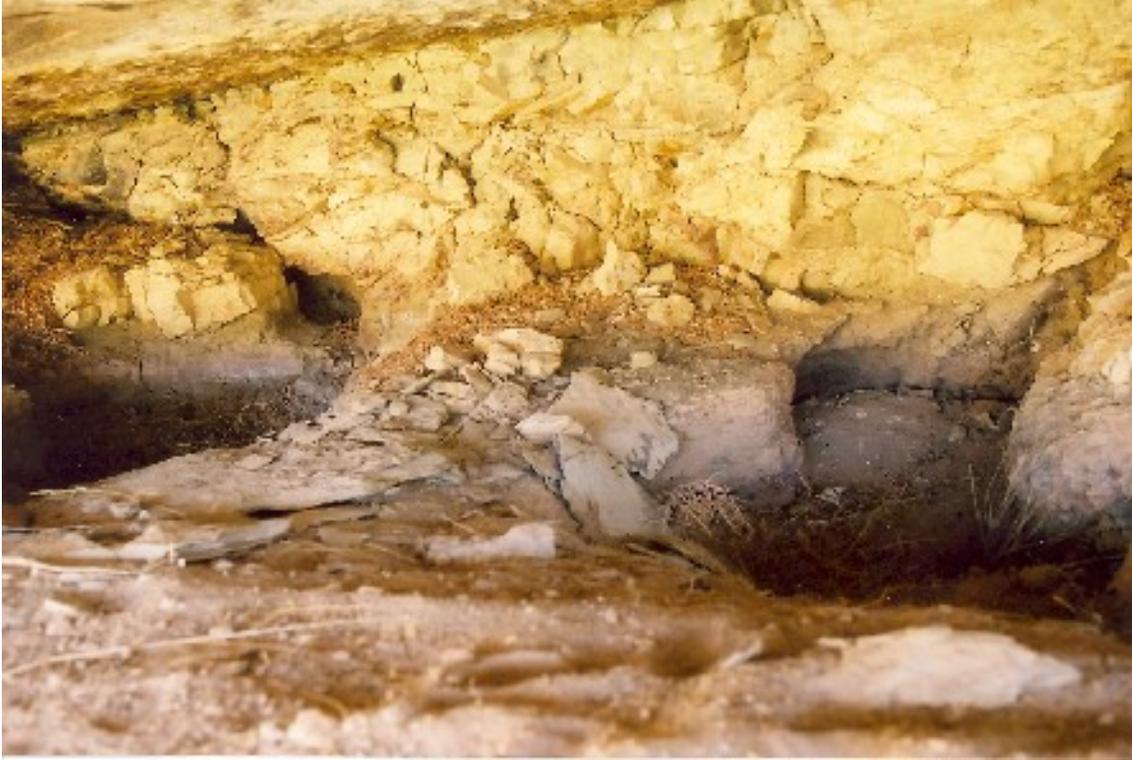
**Figure 1.3: Deep looters pits and back-dirt piles at 42Em3172, lower Range Creek Canyon.**

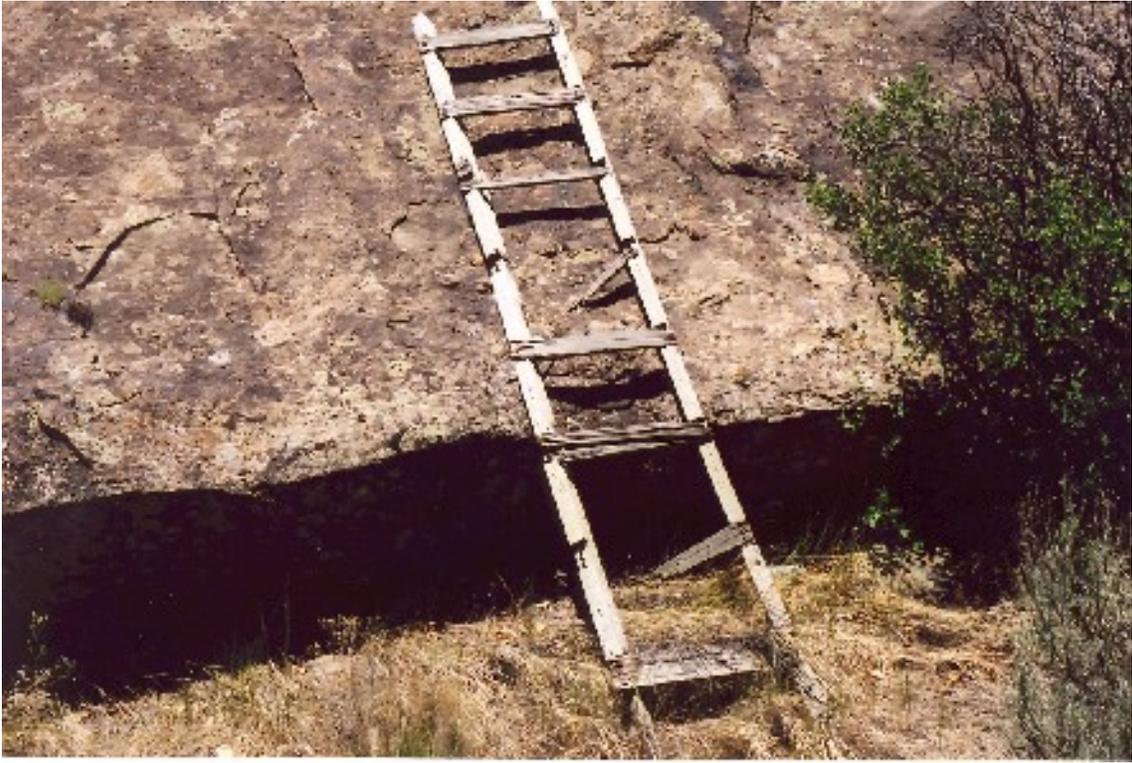
**Figure 1.4: An abandoned ladder at 42Em2887 probably used to gain access to sites on ledges.**

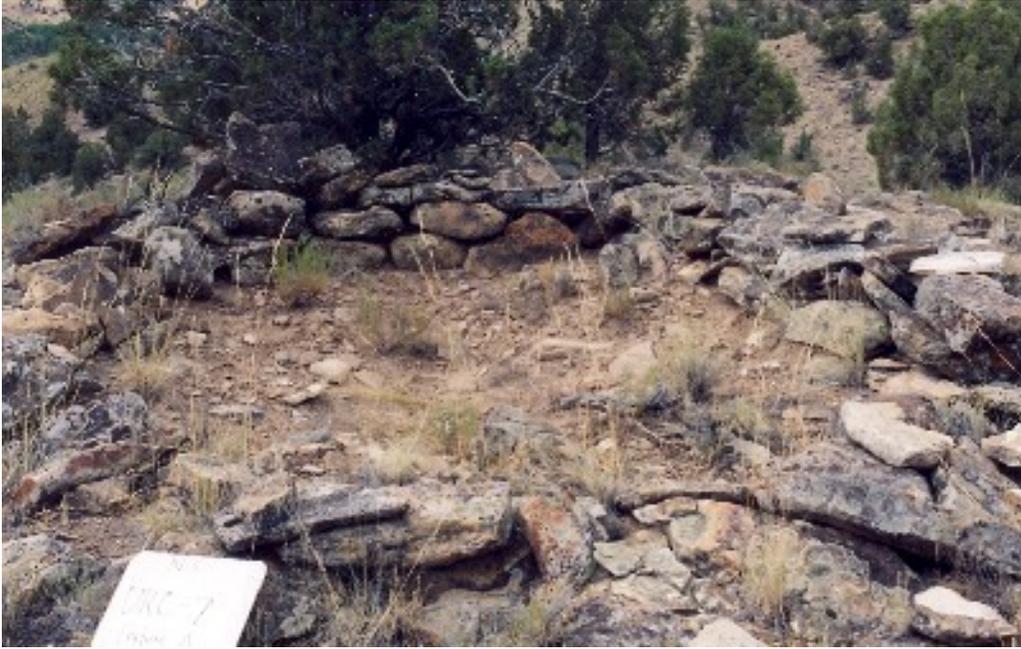
**Figure 2.14: Site 42Em753 as it appeared in 2003. Note the interior vegetation.**

At 42Em753, crews observed in 2003 evidence that the interior had been looted sometime in the past, but the looters' holes had largely refilled through natural erosion and native plants were growing inside the looted area. When the site was revisited in 2006, much of the interior vegetation had been cleared and there were fresh piles of back-dirt located outside the structure walls. Based on the amount of back-dirt and the lack of any plant growing in the back-dirt piles, it is likely individuals using shovels vandalized

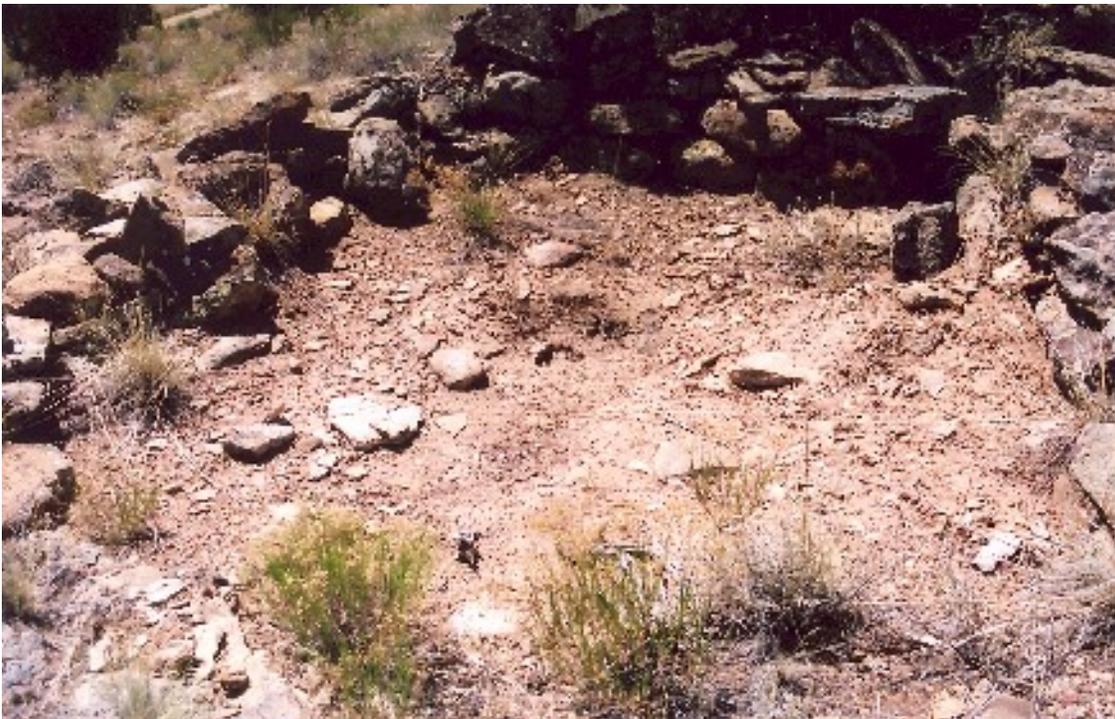
**Figure 2.15: Site 42Em753 as it appeared in 2006. Note new looters pits and cleared vegetation.**

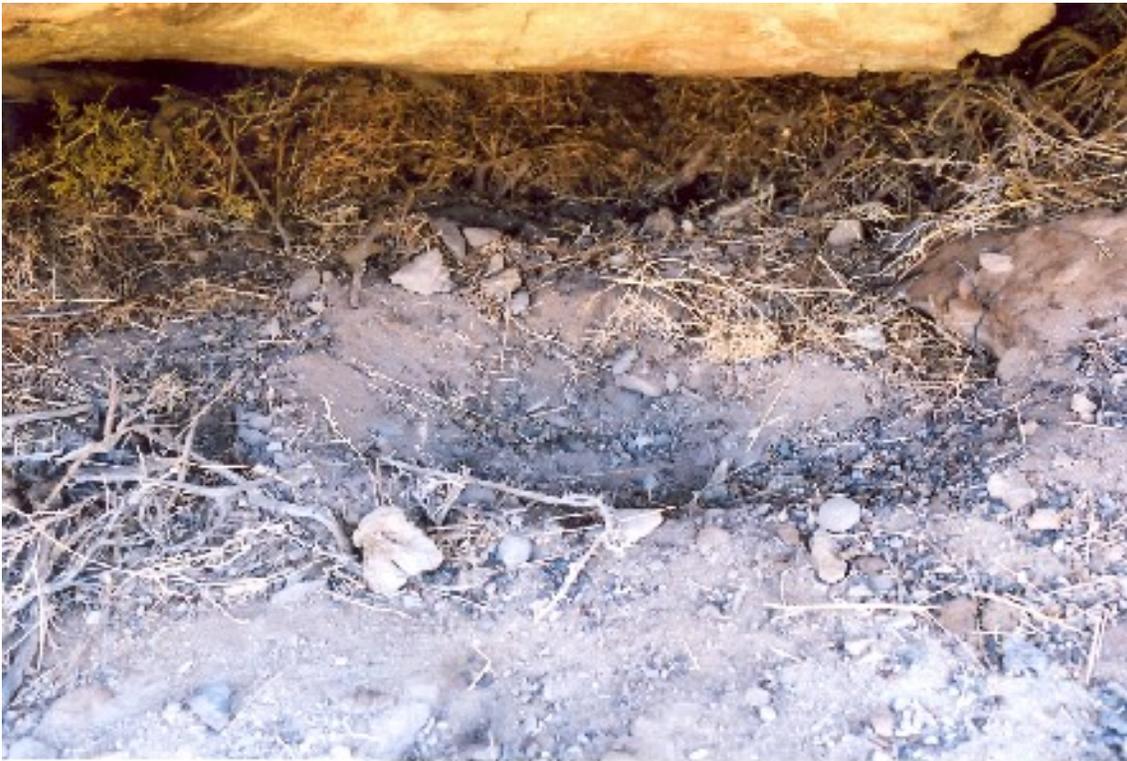
the site sometime between 2004 and 2006. At 42Em3056, interior rockshelter deposits were undisturbed in 2003 except for some rodent activity. When the site was revisited in 2006, ORV tracks led across the floodplain to the site, and there was evidence of minor digging inside the shelter (Figure 2.16). It should be noted there is no consistent law enforcement presence in this area of Range Creek.

**Figure 2.16: Small looters hole at 42Em3056 as observed in 2006.**

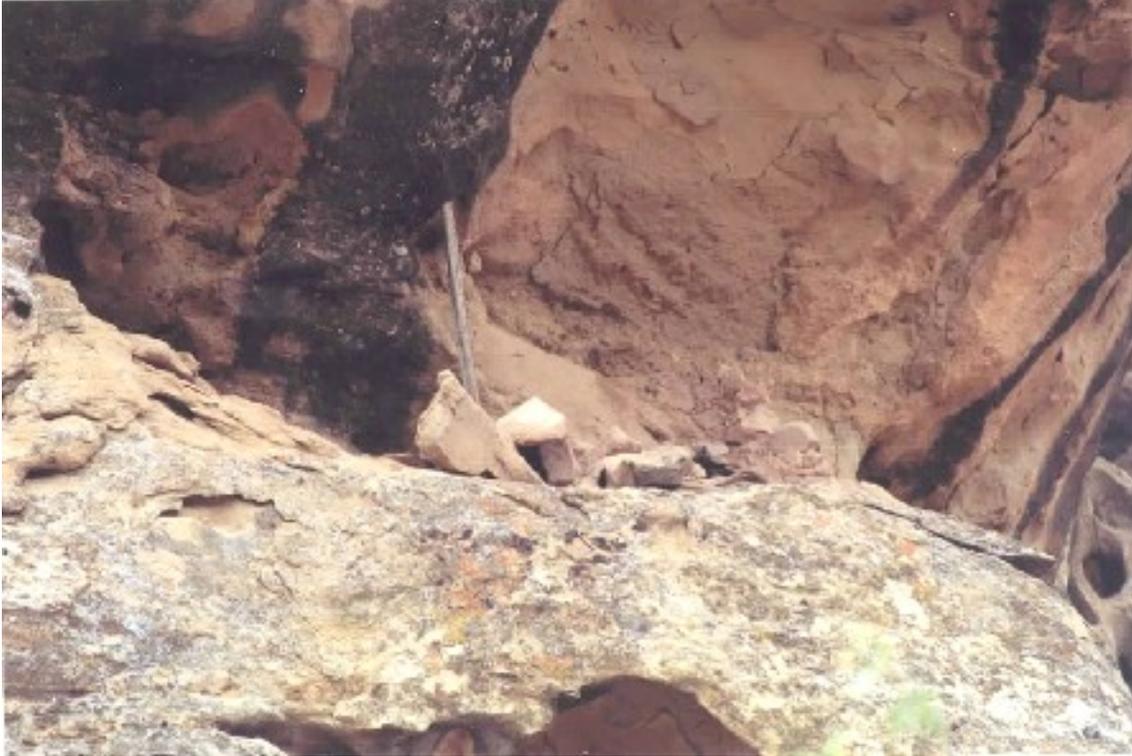
No photograph was taken of the granary feature in 1931, but it appears to be in the same condition as that described in 1931. The estimates of wall size appear to be about the same, and the vertical pole noted in 1931 remains in a vertical position (Figure 3.8). However, local informant Waldo Wilcox indicated this feature was once much more intact, and that it was damaged by trespassers. Based on visual references from the ground below (access is extremely difficult), any damage to the site by humans appears to have been minimal.

Figure 3.8: View of granary at 42Em2827 as observed in 2006. Note vertical pole described in 1931.

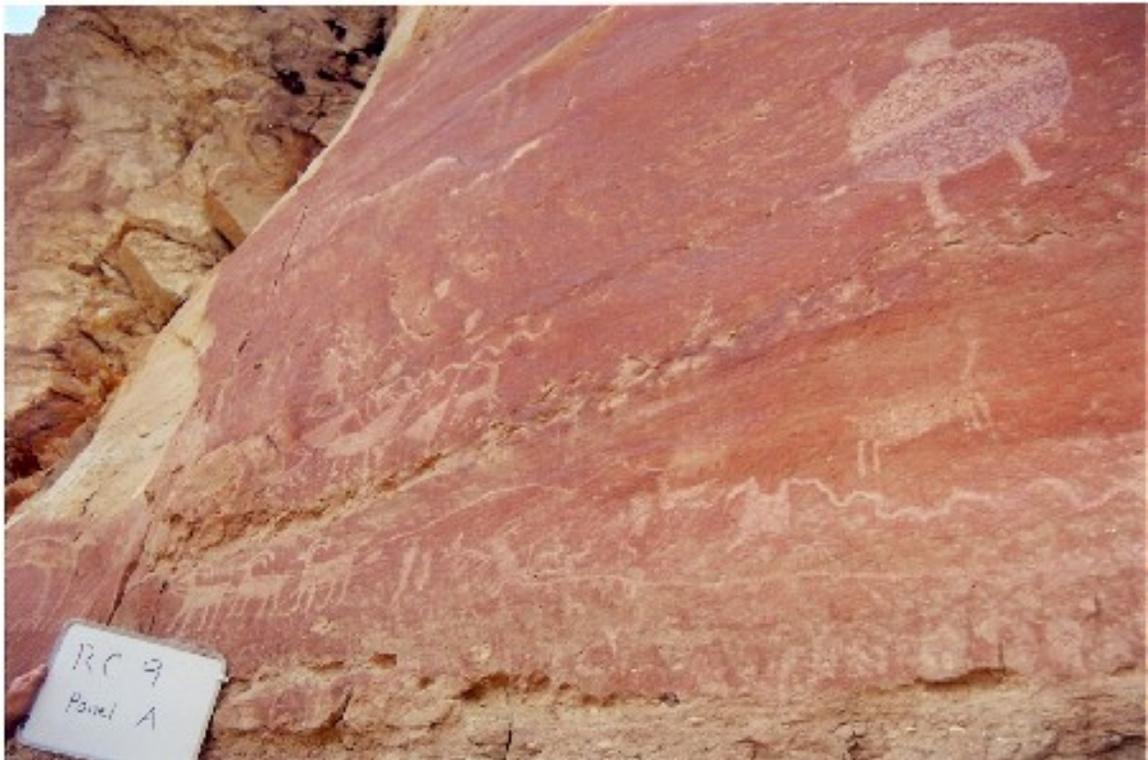
The 1931 photograph (Figure 3.14) depicts only the rock art panel, which was found in 2002 to be in essentially the same condition as that observed in 1931 (Figure 3.15). The granary structures were not accessible in 2002, and detailed observations were not possible from the slope below. This site is within the spatial range of pedestrian visitation in upper Range Creek, but it is not readily visible from the road and likely receives minimal visitation at the current time. An abundance of potsherds and lithics were observed on the slope below during a site revisit in 2004, which could be subjected to surface collection. The structural feature above the rock art panel is difficult to access without climbing gear and likely will be protected by its inaccessibility. The rock art panel is one of the more aesthetically impressive sites in the canyon, and the site will undoubtedly become the focus of considerable visitation if its location is revealed. It is recommended that public visitation to this site be discouraged. However, if the location of this site should become public knowledge, a more comprehensive investigation and data recovery should be initiated.

Figure 3.15: Rock art panel at 42Em2835 as observed in 2002 (J.D. Spangler).

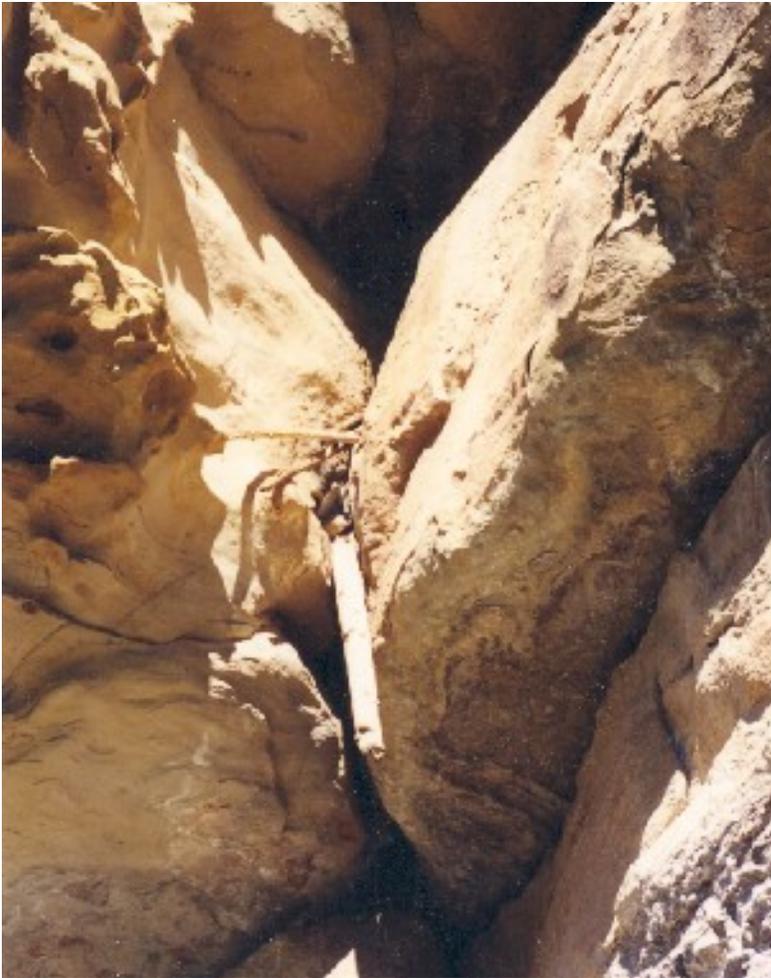
Figure 3.23: View of collapsed construction materials at 42Em3110, as observed in 2003 (J.D. Spangler)

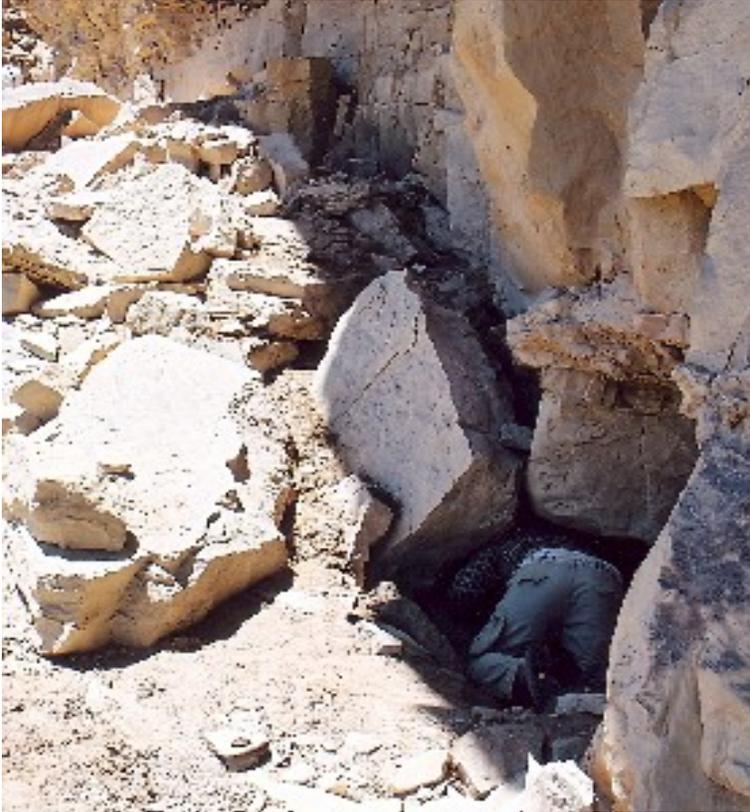
Figure 3.65: View of vandalism along base of cliff, as observed in 2004 (J.D. Spangler).

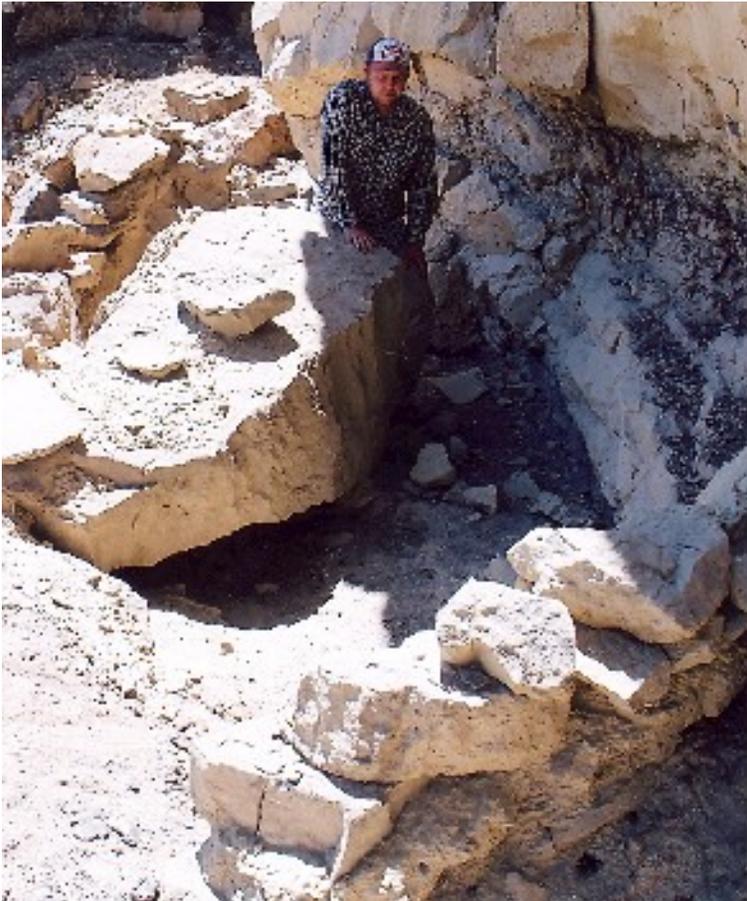
Figure 3.66: View of looted structure at 42Em760 as observed in 2004 (J.D. Spangler).
