# CHASING GHOSTS

A GIS Analysis and Photographic Comparison of  
Vandalism and Site Degradation in Range Creek Canyon, Utah

2006

BLM Contract JMP052055

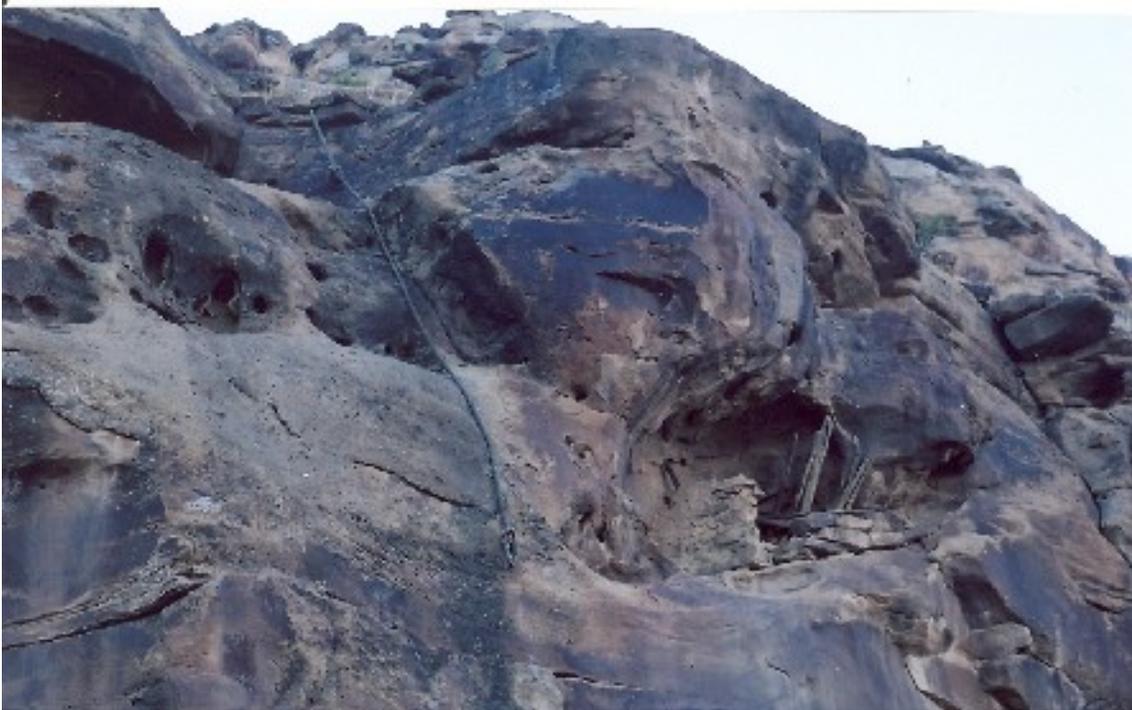
**Figure 1.5: A dangling rope used to gain access to 42Em3057**

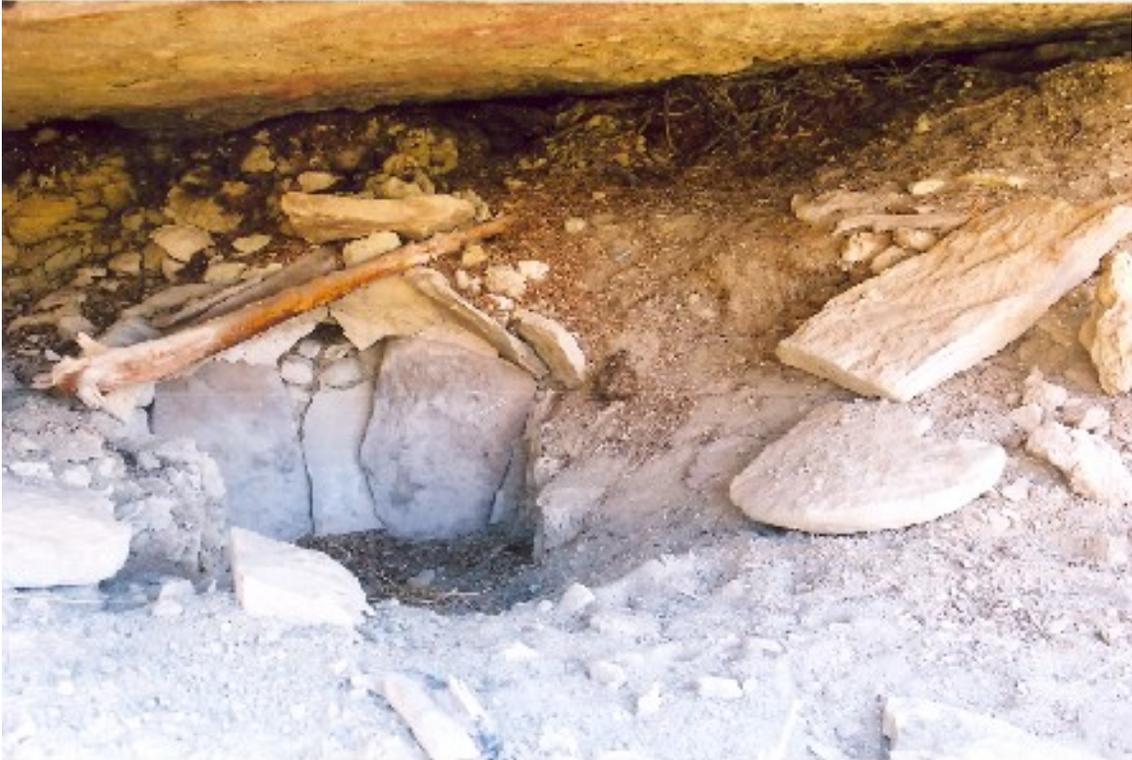
**Figure 1.6: An informant provided detailed information about a burial removed from 42Em3059.**

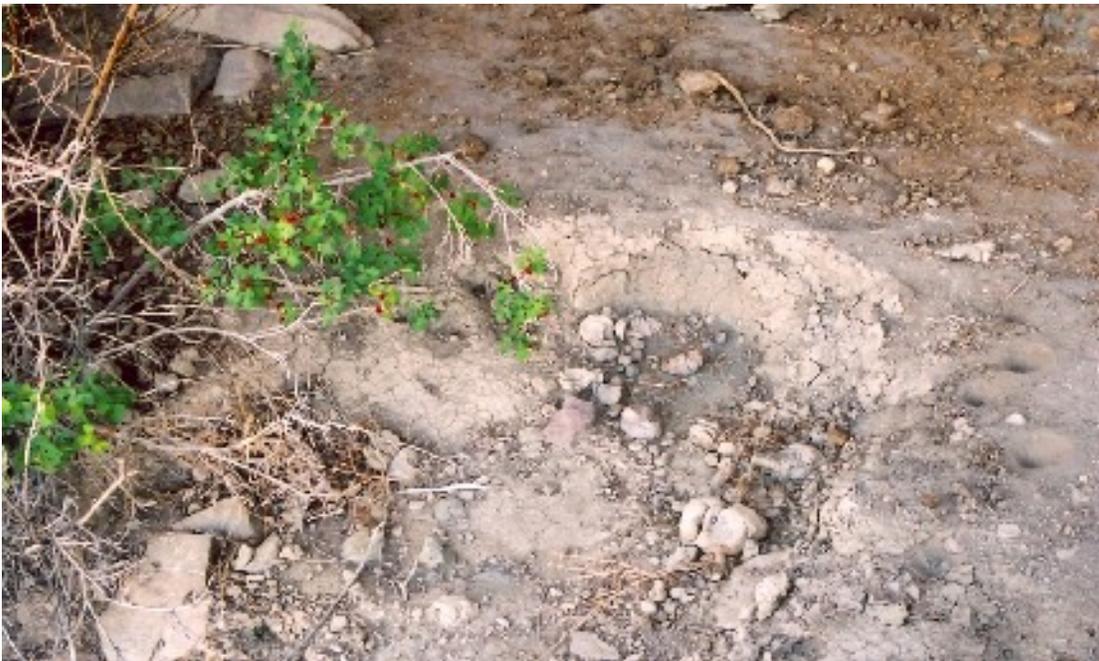
**Figure 1.7: Remnants of a Clafin-Emerson test pit at 42Em752.**

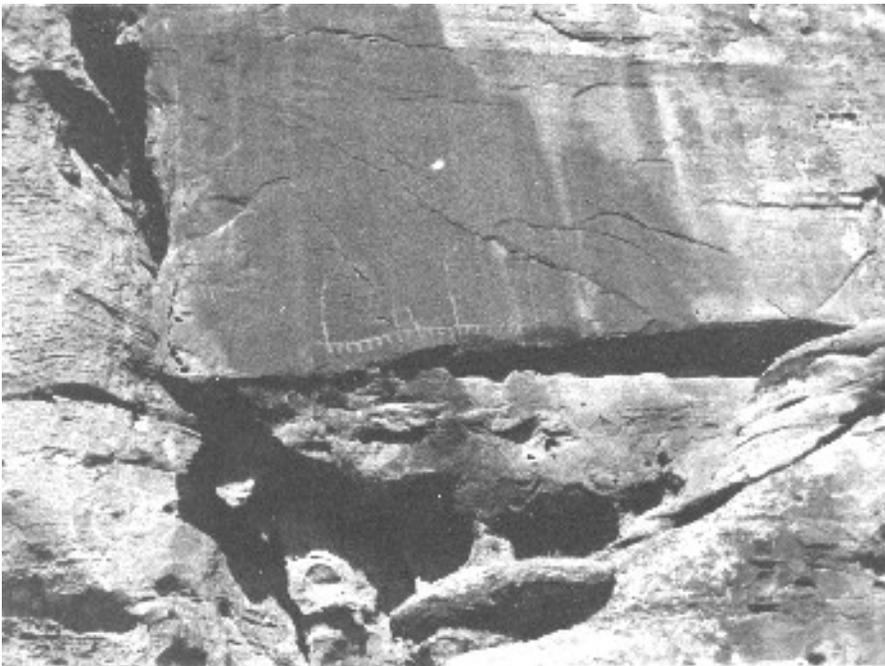
The first site apparently encountered, but not mentioned in the field notes, was 42Cb1704, a rock art panel [REDACTED] that continues to receive considerable public visitation, as evidenced by numerous pedestrian trails to the site. The panel was not described or assigned a temporary number in 1931, but it was photographed (Figure 3.2). A comparison to a 2002 photograph (Figure 3.3) indicates the site is in essentially the same condition as observed in 1931. The site is located several meters above present ground surface and is not easily accessible or susceptible to vandalism. Given the absence of associated artifacts that could be subject to surface collection and the location of the panel on a cliff face above human reach this site is appropriate for public visitation and interpretation.

Figure 3.2: View of 42Cb1704 as observed in 1931 (Peabody Museum U-31-81).

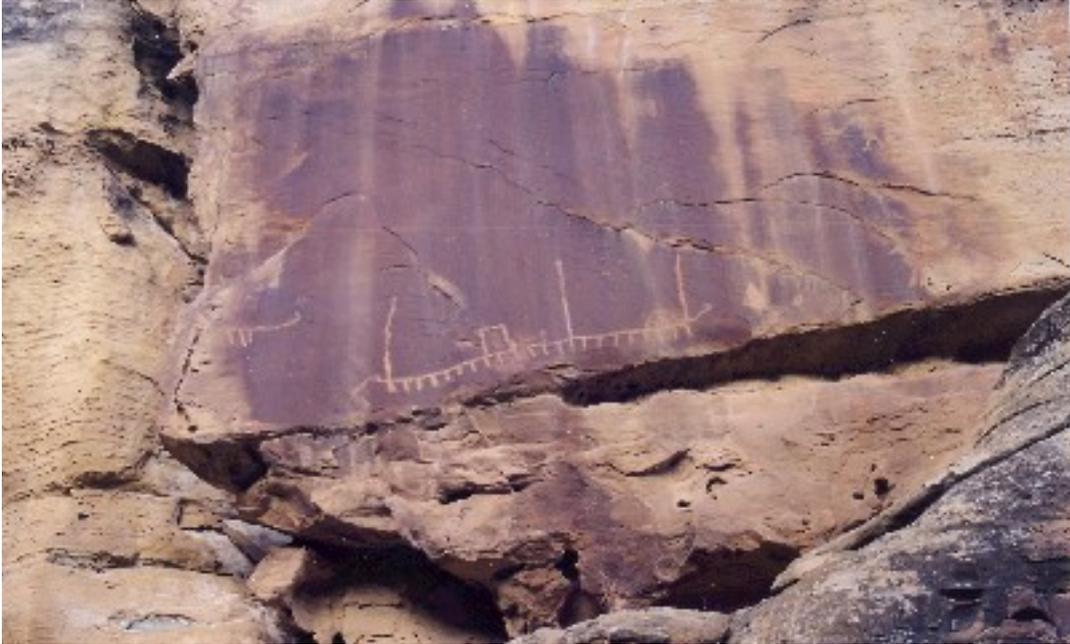
Figure 3.3: View of 42Cb1904 as observed in 2002 (J.D. Spangler).

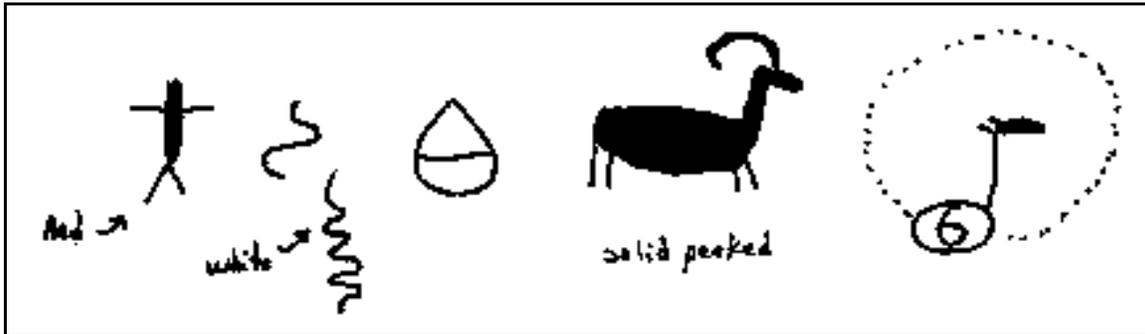
This site, documented in 2002, consists of a large rockshelter [REDACTED] that features traces of red and white pigment on the back of the shelter. A large petroglyph panel is situated on a cliff face. The Claflin Emerson Expedition offered sketches (Figure 3.4) and a limited site description, but no temporary number was assigned. Dennison described the site as:

Figure 3.4: Rock art images (shelter left figures, cliff right figures) as sketched by Dennison (1931:23).

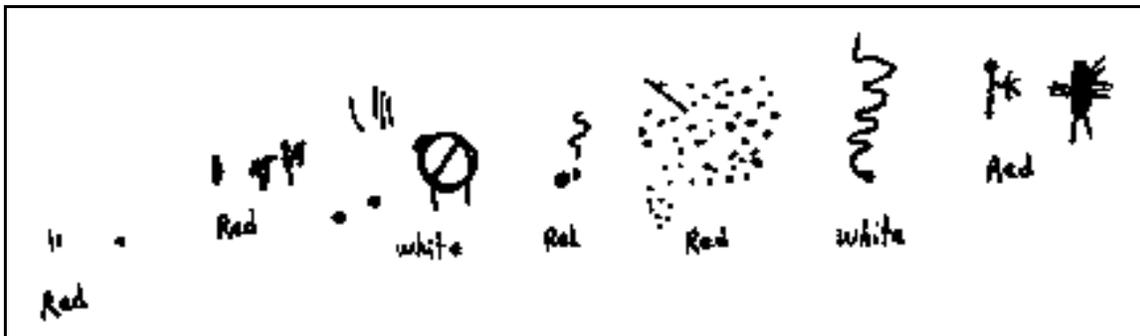
Dennison's field notes indicate that a photograph was taken (U-31-93), but this was not located during a search of the Peabody Museum archives. The 1931 notes indicate the cave was "recently" occupied, and in 2002 evidence was observed that individuals had sought shelter there in historic or modern times. There is no evidence the shelter has been looted, and most of the shelter images apparent to Dennison in 1931 are still evident (Figure 3.5), although some appear to be more eroded. The painted images on the interior of the shelter have continued to suffer natural erosion that makes them mostly indiscernible. The petroglyph panel on the northwest has likewise eroded with the horned snake figure largely indiscernible (Figure 3.6). This site is not visible from the road and likely has escaped notice by most canyon visitors. Given the potential for subsurface cultural deposits, visitation to this site should be discouraged.

Figure 3.5: Rock art images inside the shelter at 42Em2825, as sketched in 2002 (D.K. Spangler).

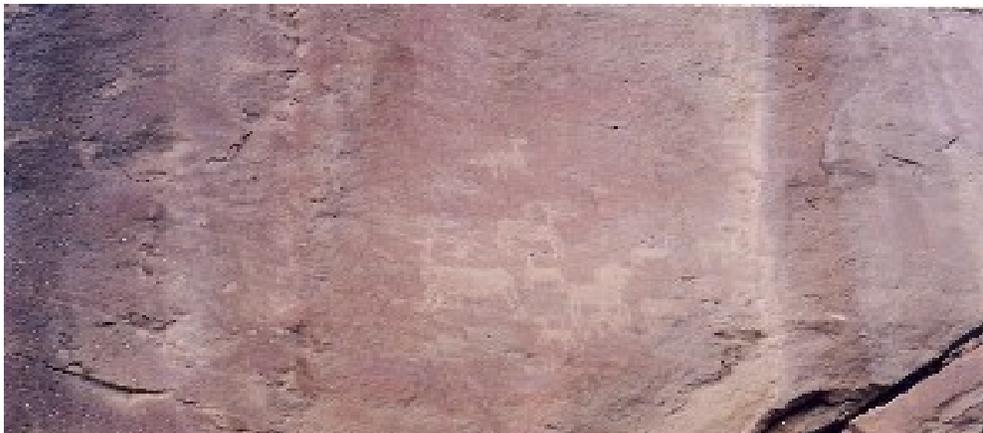
Figure 3.6: View of petroglyphs north of shelter at 42Em2825 as seen in 2002 (J.D. Spangler)

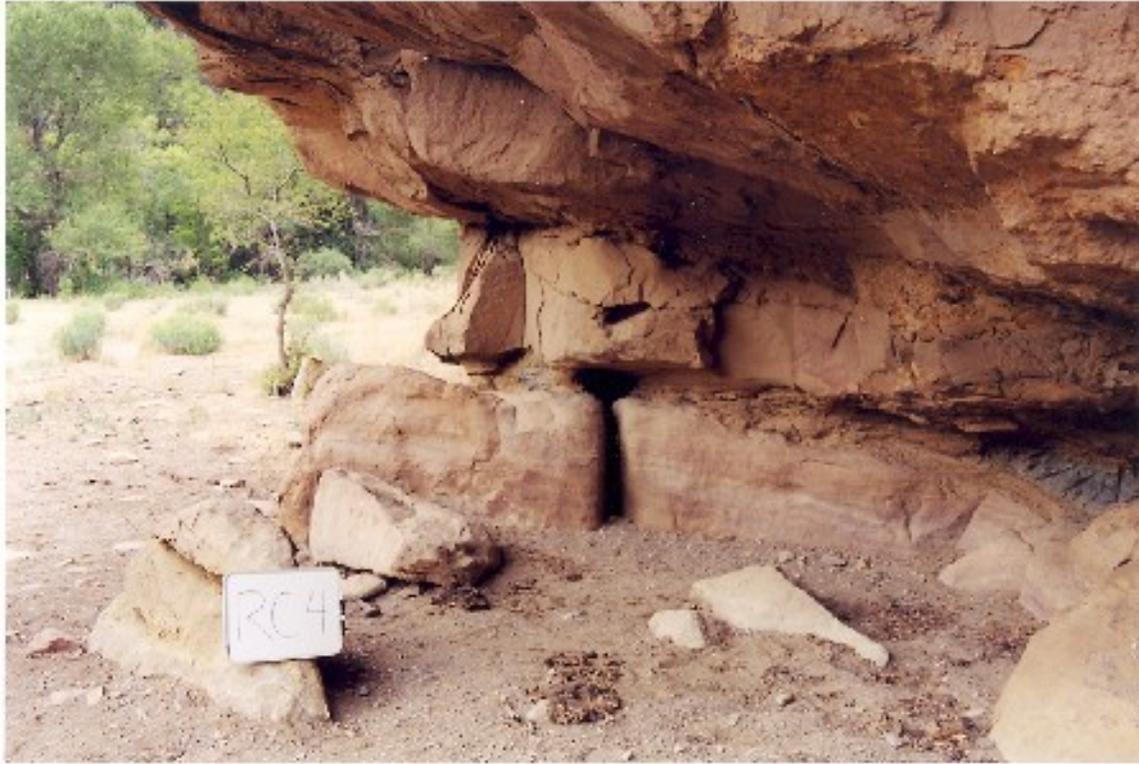
Figure 3.7: Sheltered area at 42Em2827, as observed in 2002 (J.D. Spangler).

The rockshelter below the granary has been severely impacted by livestock utilizing the large dry area as a shelter from the elements. In 1931, a groundstone tool was observed near the back wall of the shelter, but this artifact is no longer evident at the site. Also in 1931, test excavations revealed charcoal to a depth of 50 centimeters where they encountered abundant charcoal. There is no evidence of any surface charcoal, and the surface deposits are heavily disturbed, probably by livestock. An assessment of the rock art panels is more problematic. The field notes suggest the presence of red and white pictographs outside the rockshelter, but these are no longer evident. Inside the shelter are indistinct scratching and peck marks, as well as two white anthropomorphs, a white undulating line and remnants of red pigment. These figures appear to correspond to images observed and sketched in 1931 (Figure 3.9), suggesting the panel described in 1931 was located inside the shelter rather than outside.

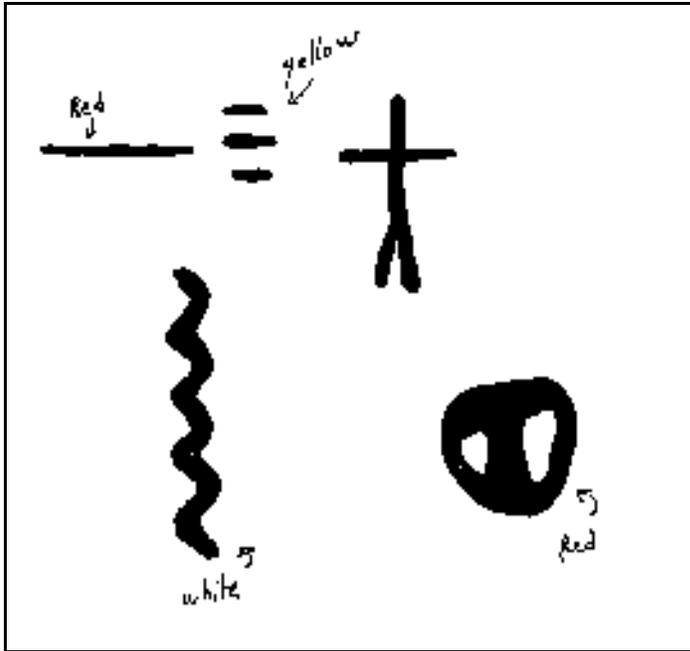
Figure 3.9: Rock art images as sketched in 1931 (Forbes 1931:51).

A comparison of the 1931 sketch to the 2002 sketch (Figure 3.10) reveals the same images are present today but at least one red circular figure has severely eroded over the past 75 years. It appears the only artifact observed in 1931 has been removed from the site. This site continues to receive heavy public visitation given its proximity to the road and the north locked gate. Since the site was revisited in 2002, significant pedestrian paths have developed around the site, and garbage has been left on the ground and stuffed into cracks inside the shelter. Given the paucity of artifacts that could be subjected to surface collecting and the inaccessibility of the architectural feature above the shelter, this site is appropriate for public visitation, interpretation and education outreach efforts, including proper site etiquette. However, the presence of subsurface deposits warrants continual monitoring of this site to ensure against illegal excavations, camping and other adverse impacts.

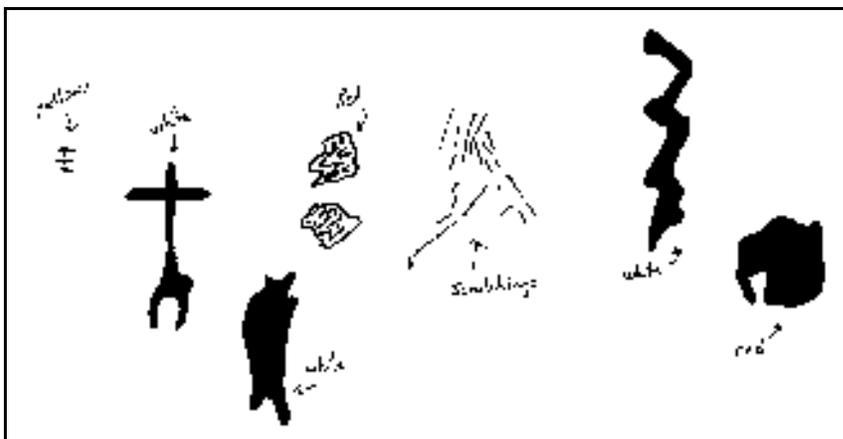
Figure 3.10: Rock art as sketched in 2002 (D.K. Spangler).

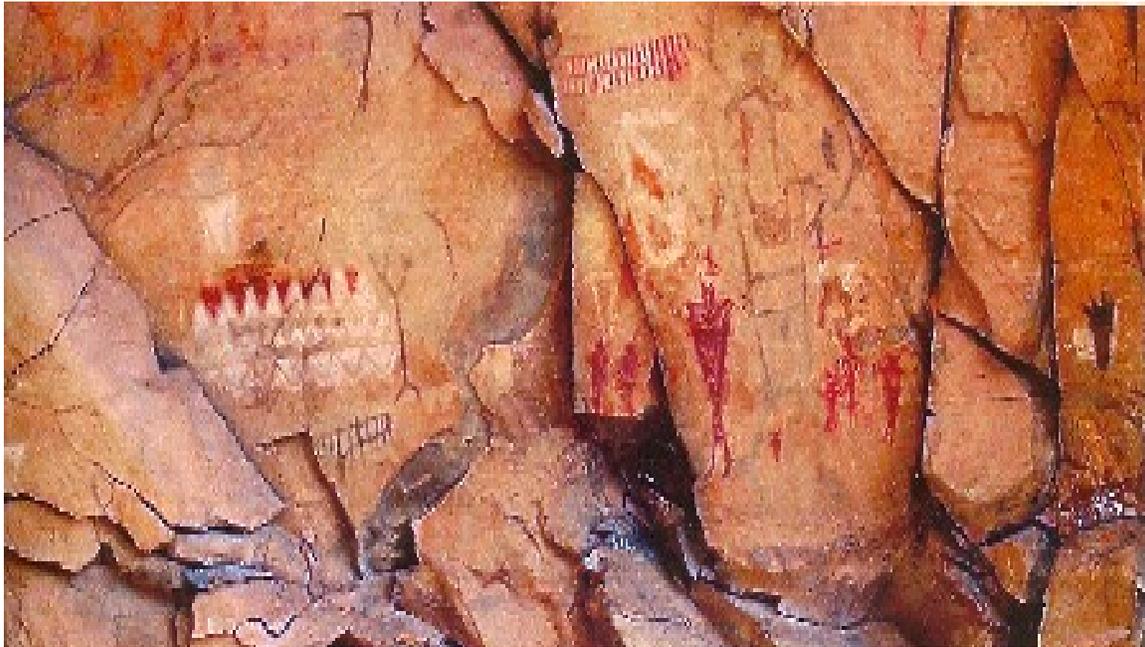
[REDACTED] This site was mentioned in the 1931 field notes, but at least three photos offer good comparisons of present site condition to that observed in 1931. This site was documented in 2002 (Figure 3.11) and, based on a comparison with the 1931 site photograph (Figure 3.12), it was found to be in essentially the same condition. However, there appears to be some evidence of natural erosion. A close-up view of a red-and-white zigzag design taken in 1931 (Figure 3.13) reveals what appears to be greater amounts of pigment and interior designs than are evident today. The colors also appear to be more vivid and detailed in the 1931 photograph, although this may be a photographic misperception. Access to this site is moderately difficult, involving backtracking up canyon more than 100 meters, ascending a steep slope and walking along on a narrow, eroding ledge. This access is likely a deterrent to significant public visitation (visitors typically view the panel with binoculars from the valley floor). Given the public safety risk of the narrow ledge and the sensitive qualities of pictograph pigments, public visitation to this site should be discouraged.

Figure 3.11: View of rock art panel at 42Em2828, as observed in 2003 (Utah Museum of Natural History).

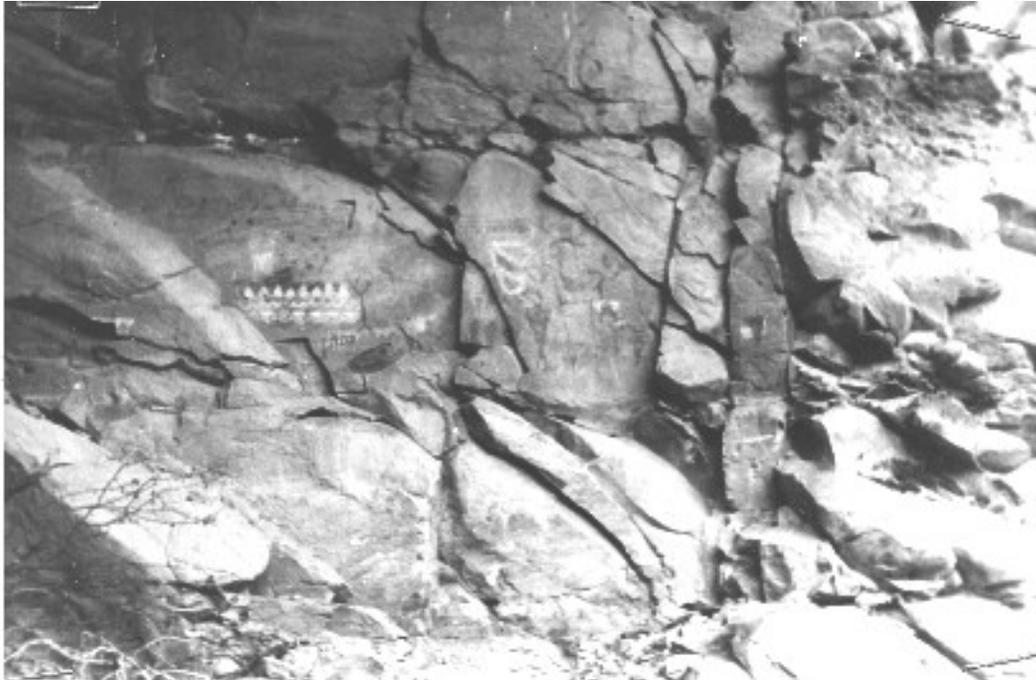
Figure 3.12: View of rock art panel at 42Em2828, as observed in 1931 (Peabody Museum U-31-164).

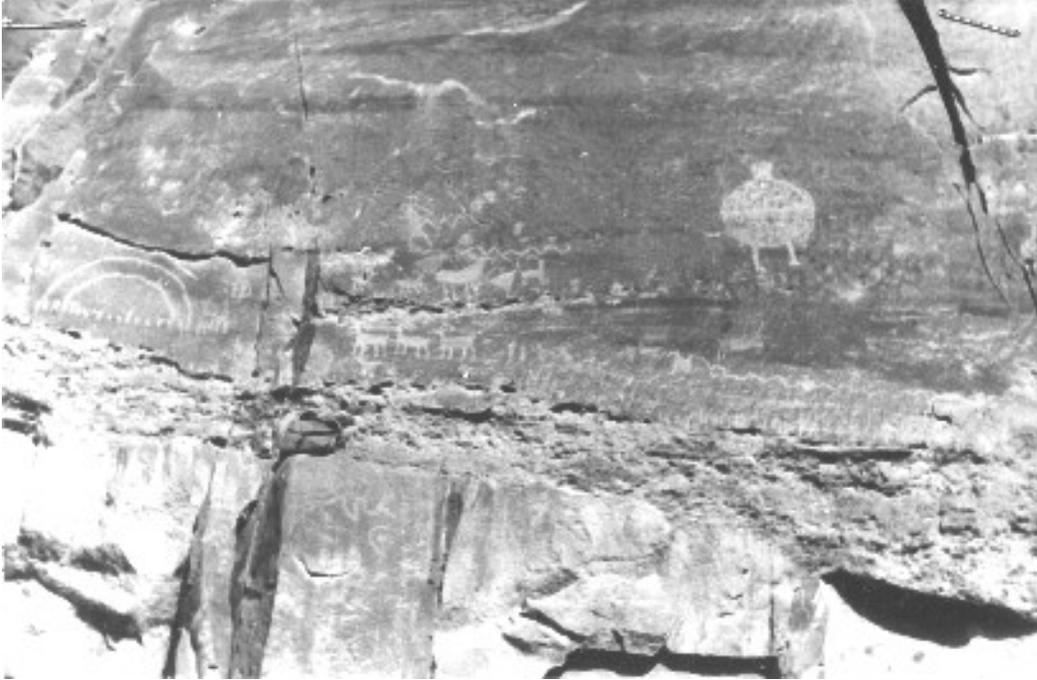
The 1931 photograph (Figure 3.14) depicts only the rock art panel, which was found in 2002 to be in essentially the same condition as that observed in 1931 (Figure 3.15). The granary structures were not accessible in 2002, and detailed observations were not possible from the slope below. This site is within the spatial range of pedestrian visitation in upper Range Creek, but it is not readily visible from the road and likely receives minimal visitation at the current time. An abundance of potsherds and lithics were observed on the slope below during a site revisit in 2004, which could be subjected to surface collection. The structural feature above the rock art panel is difficult to access without climbing gear and likely will be protected by its inaccessibility. The rock art panel is one of the more aesthetically impressive sites in the canyon, and the site will undoubtedly become the focus of considerable visitation if its location is revealed. It is recommended that public visitation to this site be discouraged. However, if the location of this site should become public knowledge, a more comprehensive investigation and data recovery should be initiated.

Figure 3.14: Rock art panel at 42Em2835 as observed in 1931 (Peabody Museum U-31-161).

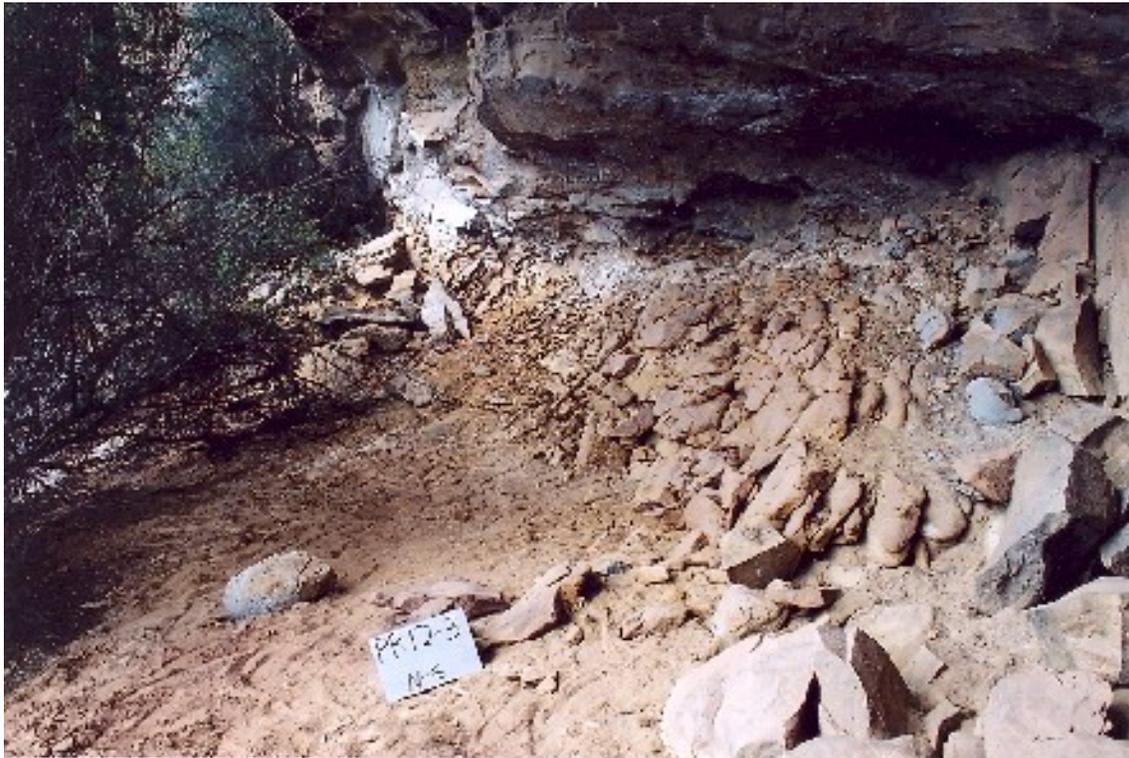
Figure 3.16: Sheltered area at site 42Em3210, as observed in 2004 (J.D. Spangler).

No photographs were taken of the site in 1931, but it appears to be in the same condition. Based on observations in 2004, there is no evidence the site has been visited

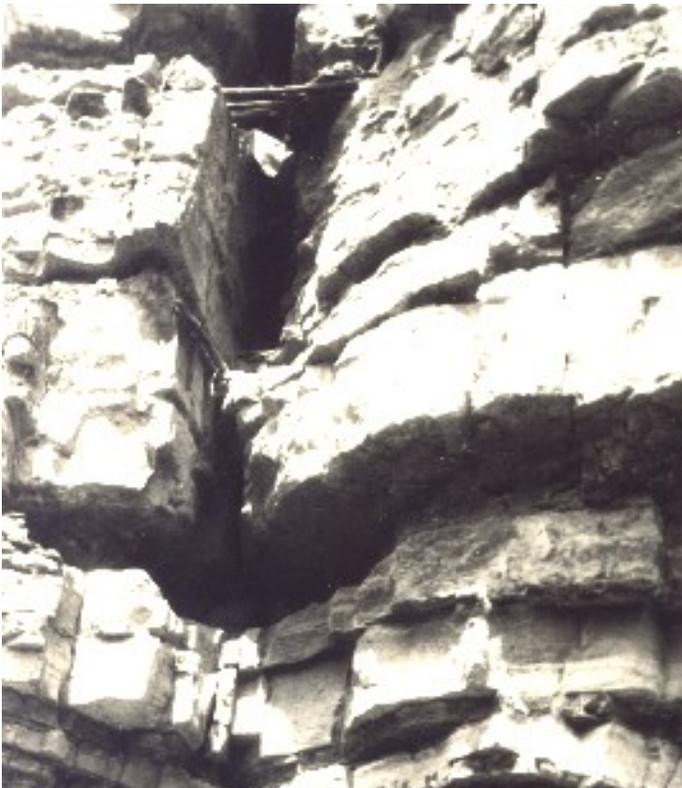
Two photographs taken in 1931 (Figure 3.24 and Figure 3.25) reveal this site to be in remarkably better condition at that time, and that it has suffered significantly from natural erosion or vandalism. The platform was clearly intact in 1931 with wooden cross beams spanning the crevice. The photographs also demonstrate that the site was accessible, suggesting that its dilapidated condition today could be the result of human efforts to access the site sometime in the past. There remains potential for cultural deposits on the ledge associated with the original structure, and public access to the structure location should be discouraged. The current condition of this site (little remains of it) would unlikely result in significant public visitation, and it is likely it would escape detection by most visitors. This site is located on the periphery of pedestrian access, and there is minimal risk of additional site degradation due to human impacts.

Figure 3.24: Site 42Em3110 as observed in 1931 with intact cross beams (Peabody Museum U-31-165).

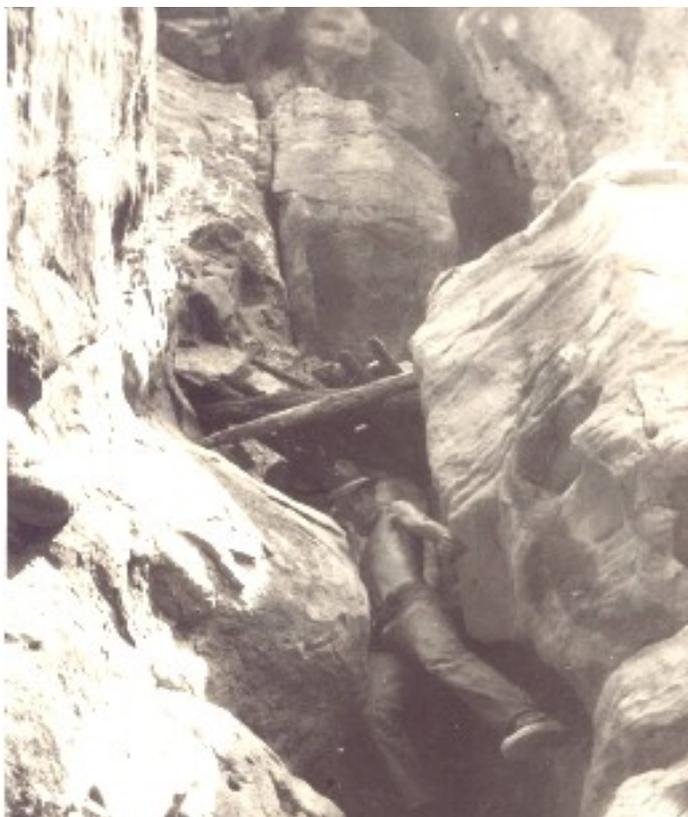
Figure 3.25: Photograph depicting accessibility of 42Em3110 in 1931 (Peabody Museum U-31-311).

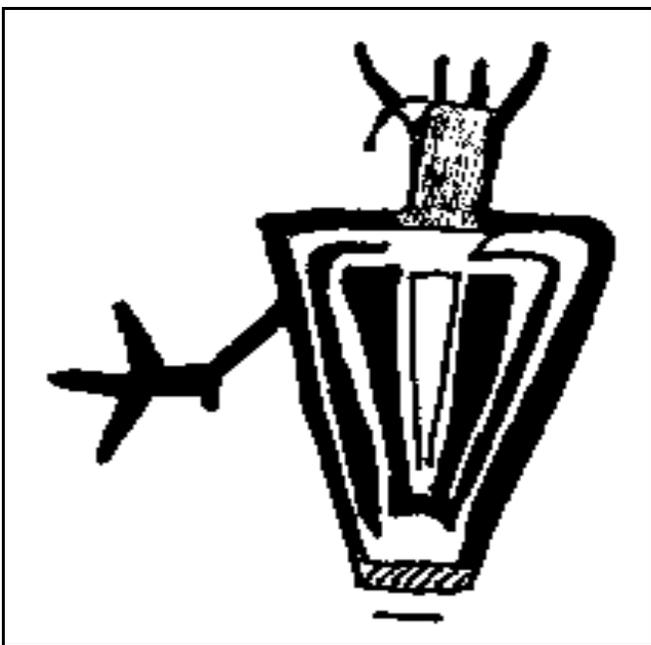
Of note, Forbes' field notes describe and illustrate (Figure 3.26) an elaborate red and white anthropomorph "about 40 meters northwest of granary" (Forbes 1931:53). The anthropomorphic figure was described as 35 centimeters tall with a white head and horns, and alternating lines of red and white. Similar figures are found at other sites in Range Creek, but this figure has not been relocated in the area described.

Figure 3.26: Rock art at 42Em3110 observed in 1931 (Forbes 1931:53). Figure not relocated.

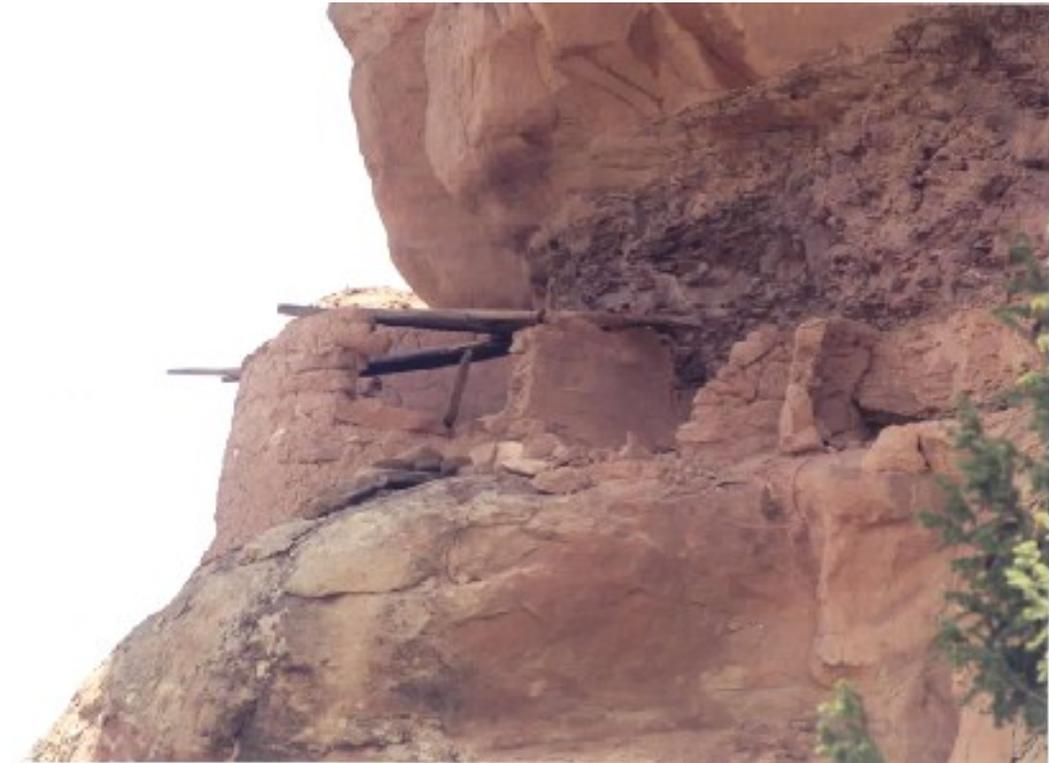
This site consists of a multi-chambered and well preserved storage facility [REDACTED] (Figure 3.27) that is easily visible, but is no longer of easy access inasmuch as the ledge accessing the site has eroded. This site was accessible in 1931 and at least for a short time thereafter (Leh 1937). It is unknown when the ledge eroded, blocking access to the site. This site, [REDACTED] remains one of the most popular among canyon visitors who are allowed vehicular access, but these universally view the site with binoculars from the road below. The site is likely beyond the range of most pedestrian visitation.

Figure 3.27: View of 42Em741 as observed in 2002 (J.D. Spangler).

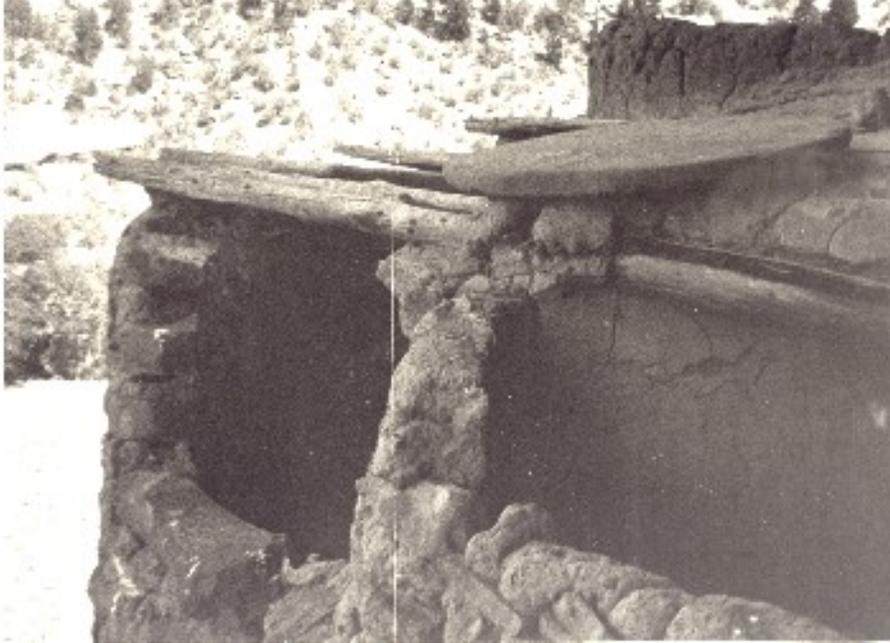
At least 10 photographs were taken of the interior of the structures, all showing a level of construction detail no longer apparent. Among these are depictions of two contiguous structures with the roof superstructure largely intact (Figure 3.28), a close-up view of the lid stone (Figure 3.29), a close-up view intact adobe wall construction (Figure 3.30) and a profile view of a perfectly intact upper wall and adjacent roof beams (Figure 3.31). The rich descriptions also included various sketches, including depictions of the rock art images not visible from the canyon bottom (Figure 3.32). Of note, 2002 field crews did not observe pictographs associated with this site. These were described and illustrated in 1931, and mention was made of one photograph that was not located in the Peabody Museum archives.

Figure 3.28: View of storage chambers at 42Em741 as observed in 1931 (Peabody Museum U-31-72).

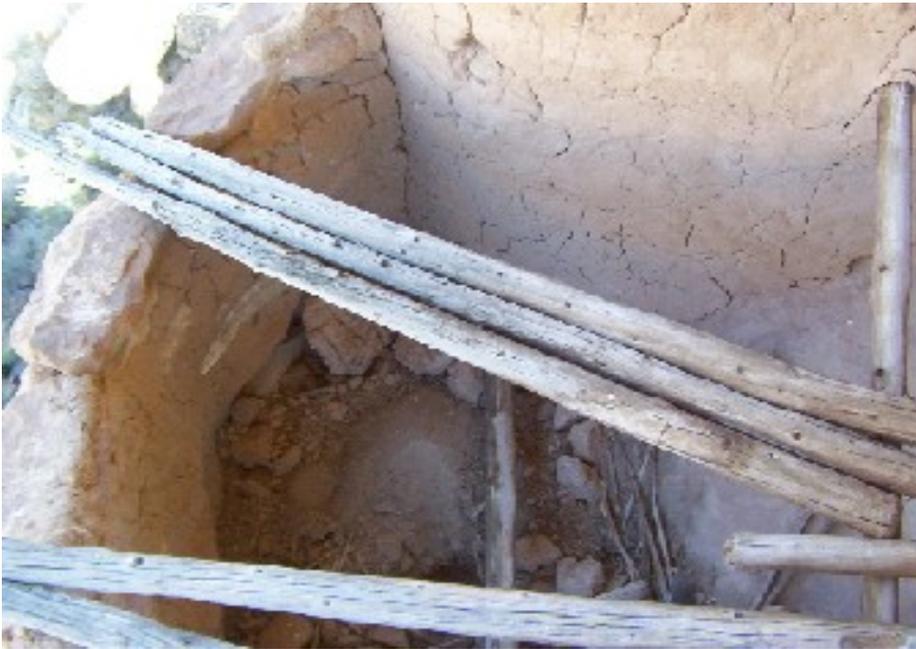
Despite its current inaccessibility, this site appears to have suffered extensively from erosion and/or vandalism. The roof superstructure has collapsed (Figure 3.33), the integrity of the walls is no longer in the pristine condition observed in 1931, and the stone

lid is no longer evident overlying the superstructure. The structures were accessed in 2005 by climbing crews, who observed cultural deposits on the interior, and remnants of vegetal binding was still present on some construction beams (Figure 3.34). The site is currently protected by its inaccessibility (the access ledge has eroded away), but it is likely that repeated visitation in the past has severely impacted the integrity of the site. Because of its visibility from the road, this site will continue to be a popular stopping point for visitors to Range Creek. Viewing the site with binoculars poses no risk to the site. However, access to the site itself should be prohibited, given the safety risks involved and the potential for subsurface deposits that could contribute significant insights into prehistoric adaptations in the area.

Figure 3.33: View of remnants of collapsed roof superstructure, as observed in 2005 (K.R. Barlow, courtesy of National Geographic Society Committee for Research and Exploration).

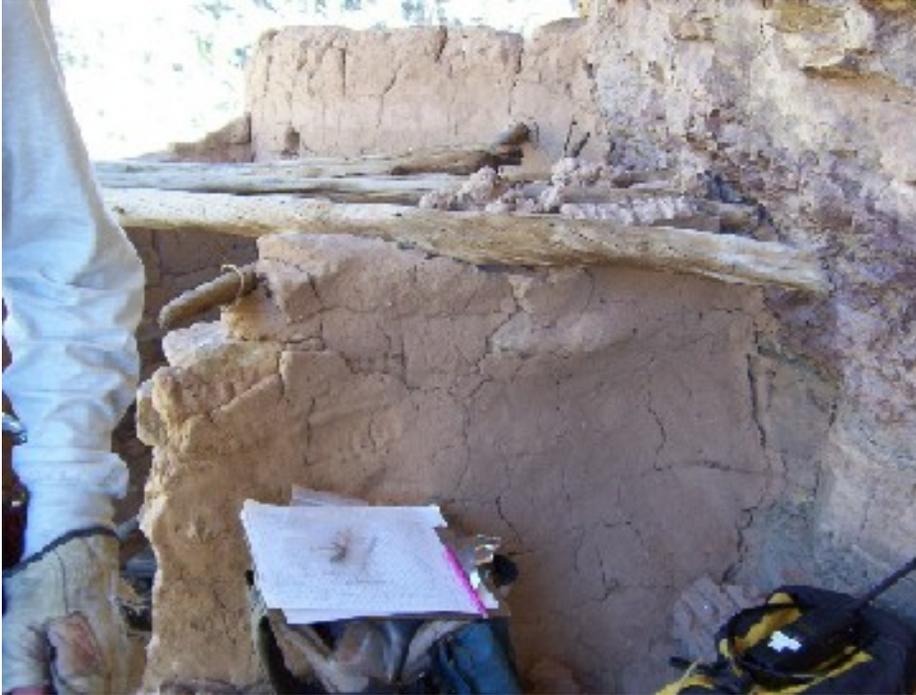
Figure 3.34: View of wall construction with vegetal binding, as observed in 2005 (K.R. Barlow, courtesy of National Geographic Society Committee for Research and Exploration).

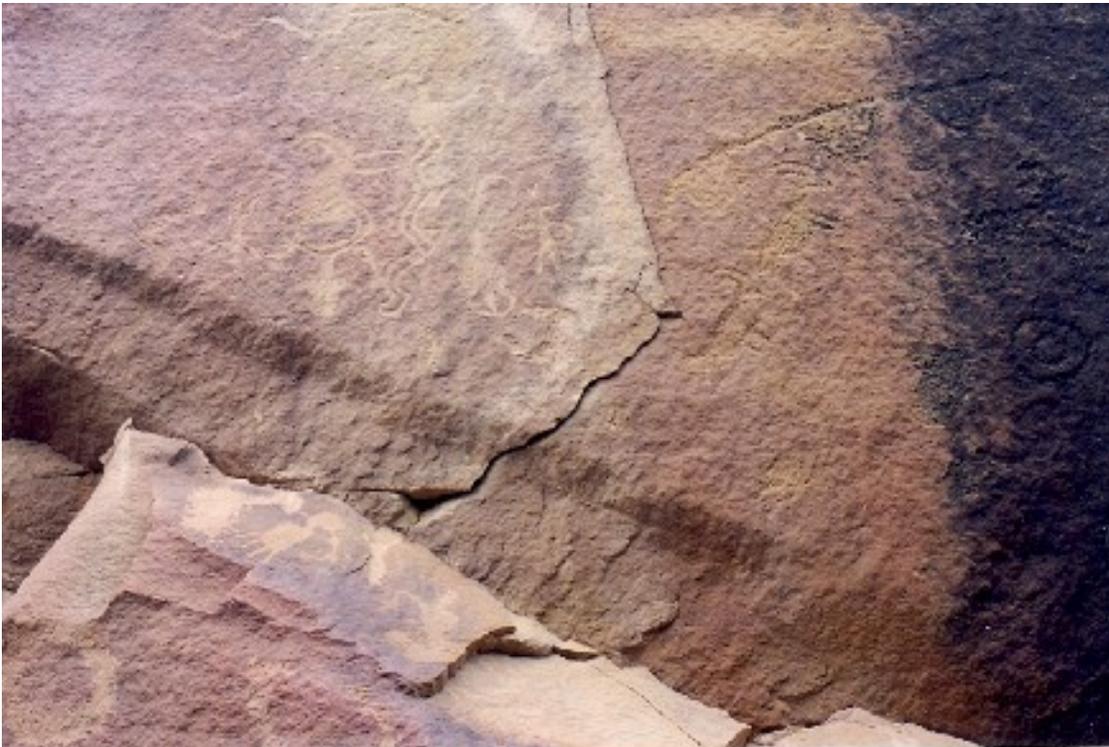
Bowers is clearly referring to two separate clusters of petroglyphs, one located next to the road and illustrated in a 1931 photograph (Figure 3.35) and the others located about 40 meters away and at the top of a talus slope about 10 meters above the valley floor. During site documentation in 2002, these were assigned two separate site numbers (42Em2844 for the panel next to the road and 42Em2845 for the higher panel). Although the quality of the photograph is not great, it appears the site is in the same condition today (Figure 3.36) as that observed in 1931. Original site records indicate a second photograph

Figure 3.36: View of petroglyph panel at 42Em2844, as observed in 2002 (J.D. Spangler).

These sites remain popular destinations for canyon visitors with motorized access. In the absence of evidence for subsurface deposits, public visitation to the panels should be allowed, but they should also be monitored for future site degradation, including vandalism and graffiti. This site would also be appropriate for cultural resource interpretation and education outreach.

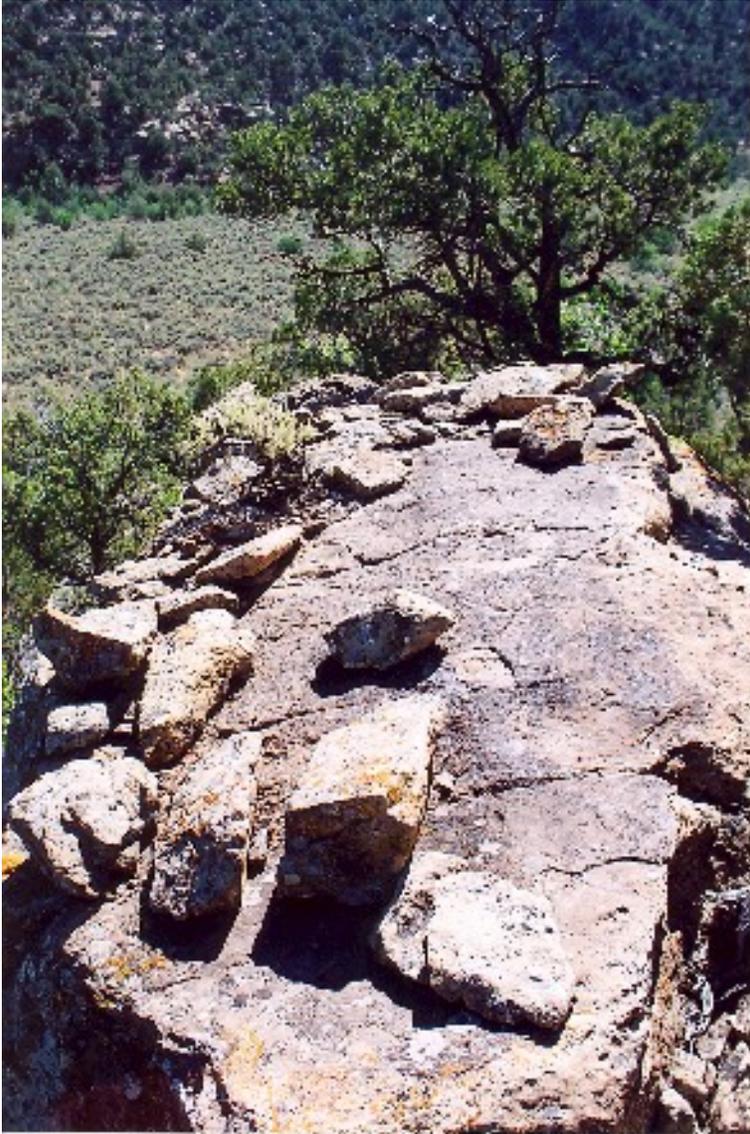
This site, documented in 2004, consists of an open, drylaid structure on top of a stone outcrop about 15 meters above and overlooking the floodplain (Figure 3.37). An associated rubble mound and residential detritus suggest additional structures were once part of the site, or that the surface structure was once much larger and has since collapsed. The site was described by Bowers as:

No photographs were taken of the site in 1931, and the description offered is minimal and not conducive to a comparison of current site condition to that observed in 1931. Generally, it appears the site is in the same condition with no obvious evidence of human impacts or visitation. This site,

Figure 3.37: View of wall remnants at 42Em3215, as observed in 2004 (J.D. Spangler).

is beyond the range of pedestrian visitation and likely will not be impacted further. The presence of residential detritus (potsherds, lithic flakes) suggests the potential for subsurface deposits, and visitation to this site and others nearby that also have surface artifacts should be discouraged. Regular monitoring of this site is also recommended.

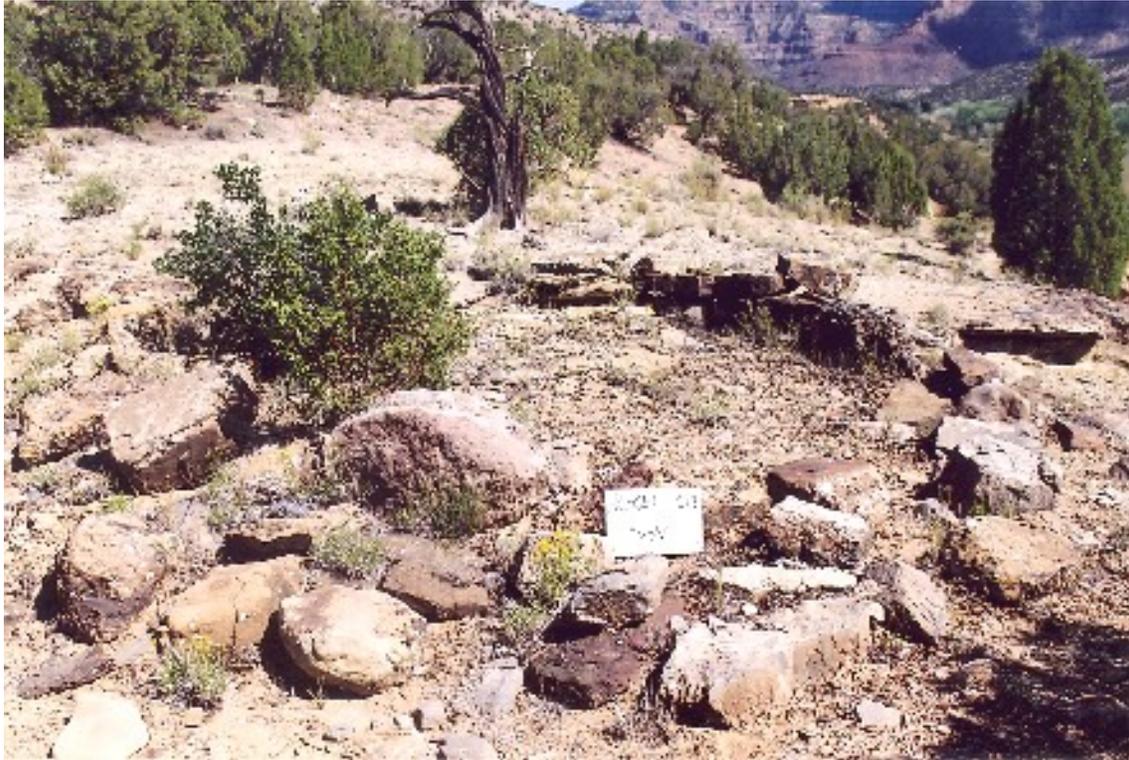
This site consists of a typical open residential structure constructed of unmodified sandstone slabs situated on the edge of a ridge overlooking the valley floor (Figure 3.40). This structure, [REDACTED], appears to be in good condition, but with few surface artifacts. This site was described by Bowers as:

No photographs were taken of this site in 1931, and given the sparse description that was offered, it is not possible to compare site condition today versus that observed in 1931. Given the proximity of this site to historic ranching operations in lower Range Creek, the site has likely been visited repeatedly over the years, and surface artifacts have undoubtedly been collected. The site appears to be in good condition, with no evidence of looters holes or toppled walls. This site is within the spatial range of pedestrian visitation from the south gate, and visitation could likely be accommodated without substantial impact to the resource. However, because the most direct access to this site is by crossing

Figure 3.40: View of 42Em3323, as observed in 2004 (J.D. Spangler).

private land, it is recommended that public access not be allowed without clearly designated pedestrian routes that traverse only public lands.

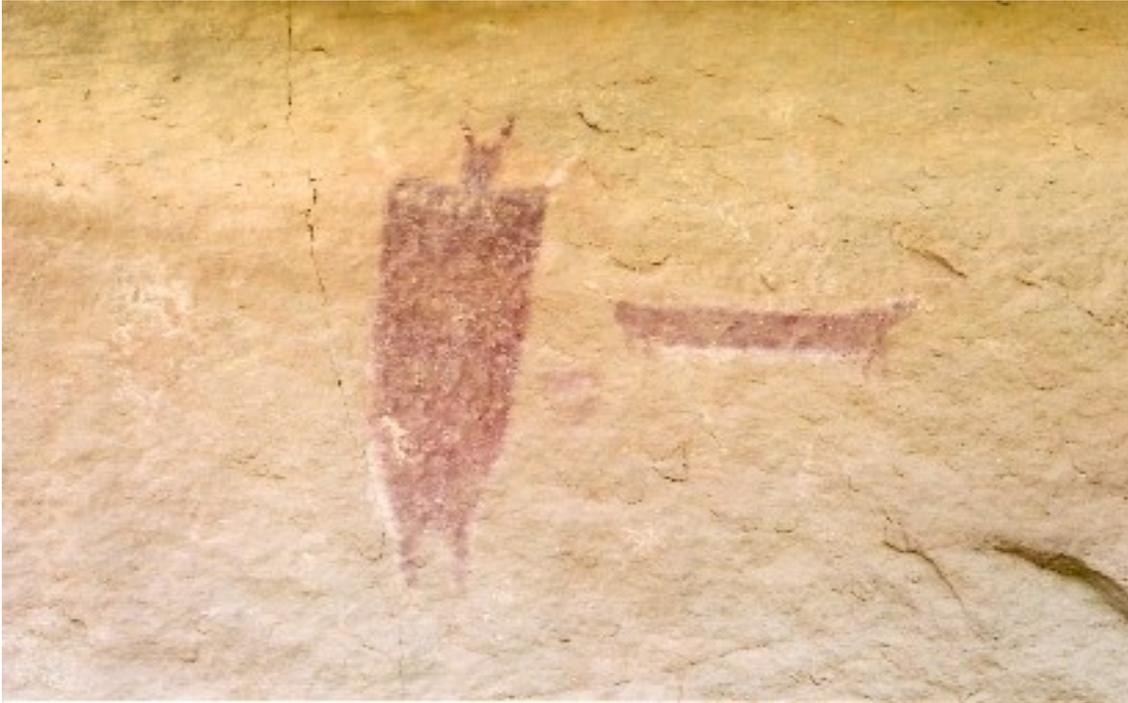
This pictograph panel is located [REDACTED] [REDACTED]. It consists of an anthropomorph in red and white, and a long thin quadruped, also in red and white (Figure 3.41). This site was described as:

Dennison indicated photograph U-31-83 was taken at this site, but this photograph was not located in the Peabody Museum archives. The sketches in Dennison's journal (Figure 3.42) leave no doubt this is the site he is referring to, but the absence of a photograph or detailed notes makes a site condition assessment difficult. Of note, Dennison mentioned yellow pigment on the tail of the quadruped which was not observed when the site was documented in 2002. This suggests that erosion is an ongoing problem at this panel. There is nothing evident here to suggest adverse human impacts. This site is visible from the road and within the range of pedestrian access from the south locked

Figure 3.41: Pictograph panel at 42Em2879 as observed in 2006 (J.D. Spangler).

gate, and therefore likely receives some visitation. However, the site is located on private property and public visitation should be discouraged.
