# CHASING GHOSTS

A GIS Analysis and Photographic Comparison of  
Vandalism and Site Degradation in Range Creek Canyon, Utah

2006

BLM Contract JMP052055

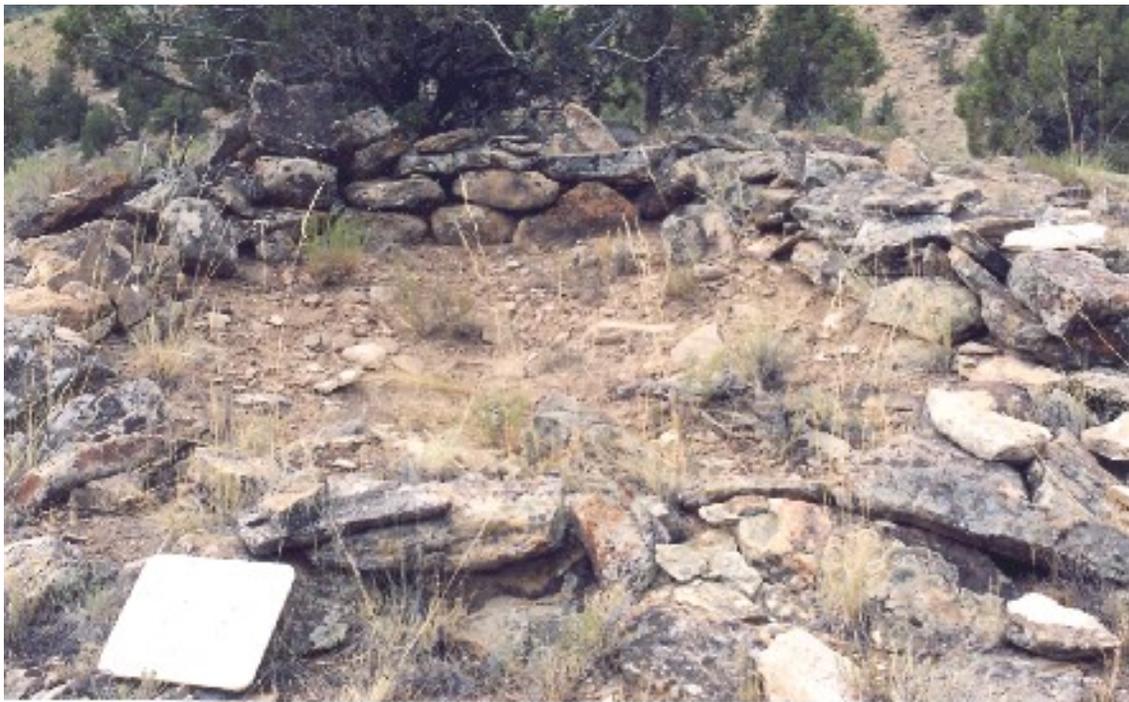
This site consists of two contiguous open residential structures located on a ridge line with a commanding view of the valley floor [REDACTED] (Figure 3.45). This site has been looted in the past, and it also appears to have been vandalized since its re-documentation in 2003. When the site was revisited in 2005, fresh back-piles of dirt from the interior of the primary residential structure were observed outside the structure walls. This site was described only briefly by Bowers as:

Figure 3.45: View of 42Em753, open residential site as observed in 2003 (J.D. Spangler).

The site was not photographed in 1931, and the minimal description makes it impossible to determine if the site had been impacted by humans at that time. Because this site has abundant surface artifacts and is located on private land, public visitation to this site should not be allowed, and regular law enforcement monitoring is recommended.

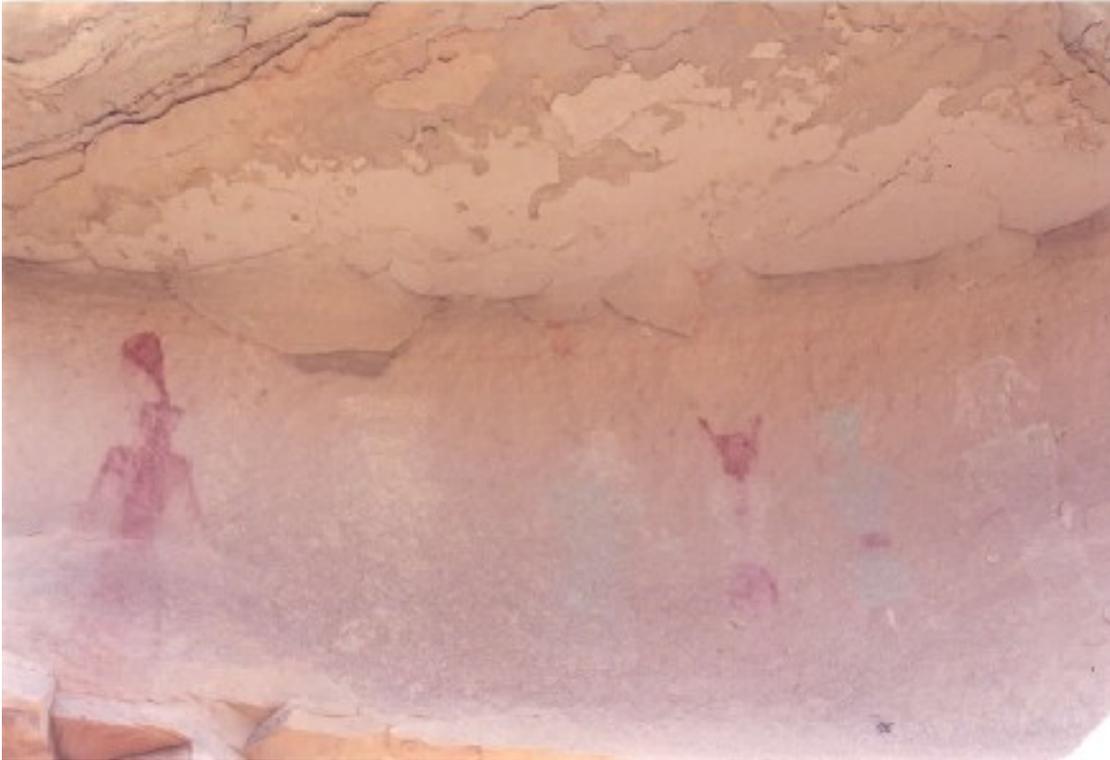
Figure 3.46: View of polychrome pictographs at 42Em2881, as observed in 2002 (J.D. Spangler).

This site was documented in 2002 and found to be in essentially the same condition as that observed in 1931. The 1931 photograph at this site (Figure 3.47) suggests that the figures may have been somewhat more vivid in 1931, given the clarity of the images despite primitive camera equipment. The storage cists below the rock art were vandalized sometime in the past, but the Claflin Emerson field notes suggest this damage was present in 1931, and that excavations at that time may have further damaged the structures. This site, located an easy walk from the south locked gate, remains among the most visited of any in lower Range Creek. Given that this site is located on private land, public access should not be allowed. However, it will likely be difficult to deter public visitation (it is well known). It is recommended that the BLM negotiate a pedestrian right of way for public visitation that will alleviate trespassing concerns. Given the abundance of other archaeological sites in the immediate area that have not been vandalized, it is also recommended that public access be limited to the pictograph panel at 42Em2881.

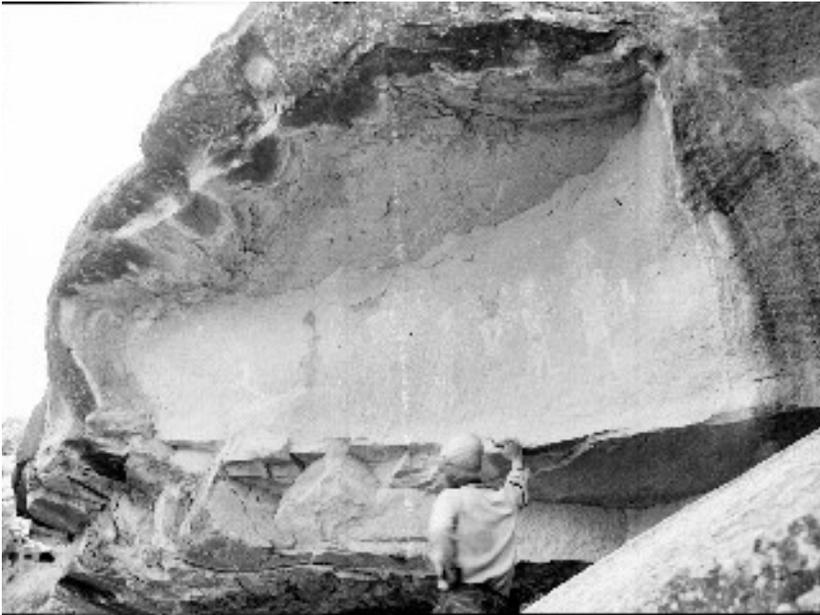
Figure 3.47: View of pictographs at 42Em2881 in 1931 (Peabody Museum U-31-251).

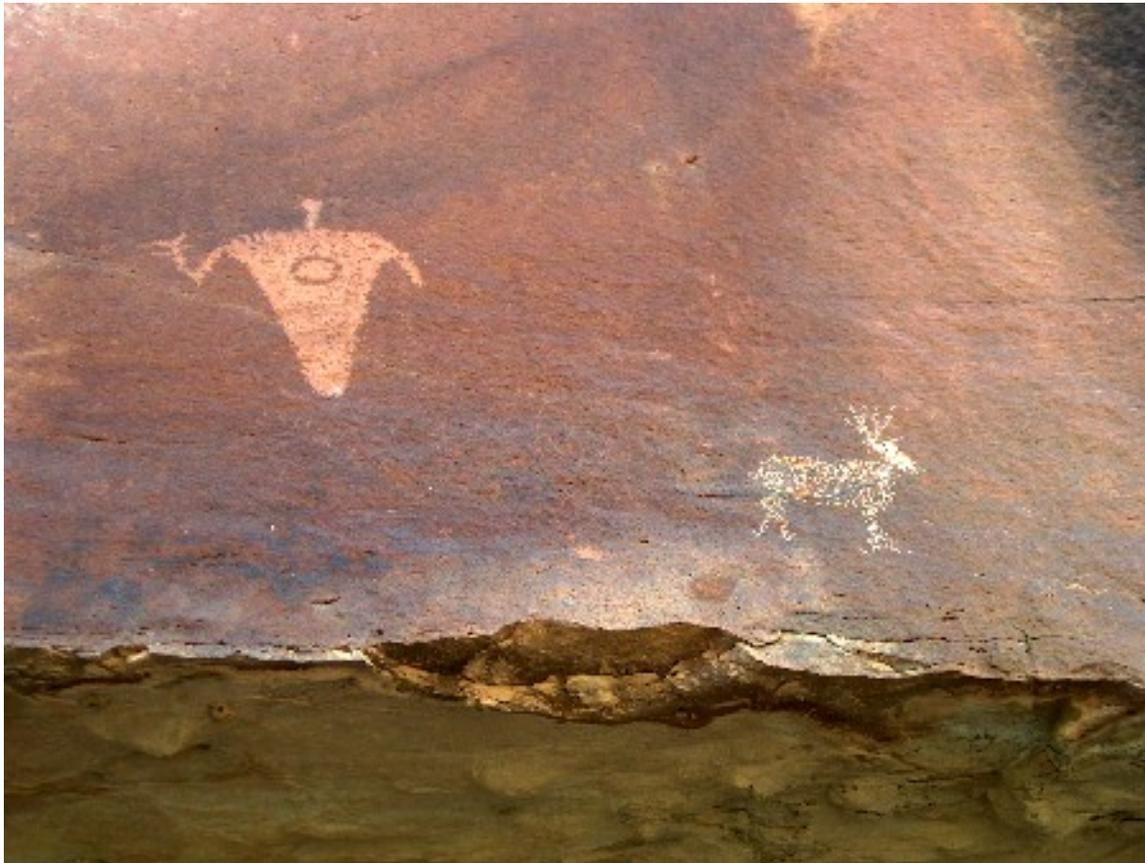
When the site was formally documented in 2002, crews noted the quadruped exhibited a different, less precise pecking style compared to the adjacent human figure. But at that time there was no reason to doubt that it was of aboriginal derivation. However, the 1931 photograph (Figure 3.50) revealed that the quadruped was not present at that time, and that it is an addition by local residents or visitors to the canyon sometime over the past 75 years.

[REDACTED] It is outside the area of restricted public access and consequently receives considerable public visitation. This site would be appropriate for public education as to the impacts of graffiti. It should also be monitored for future adverse impacts.

Figure 3.48: Site 42Em2882 as observed in 2002 with crude quadruped (J.D. Spangler).

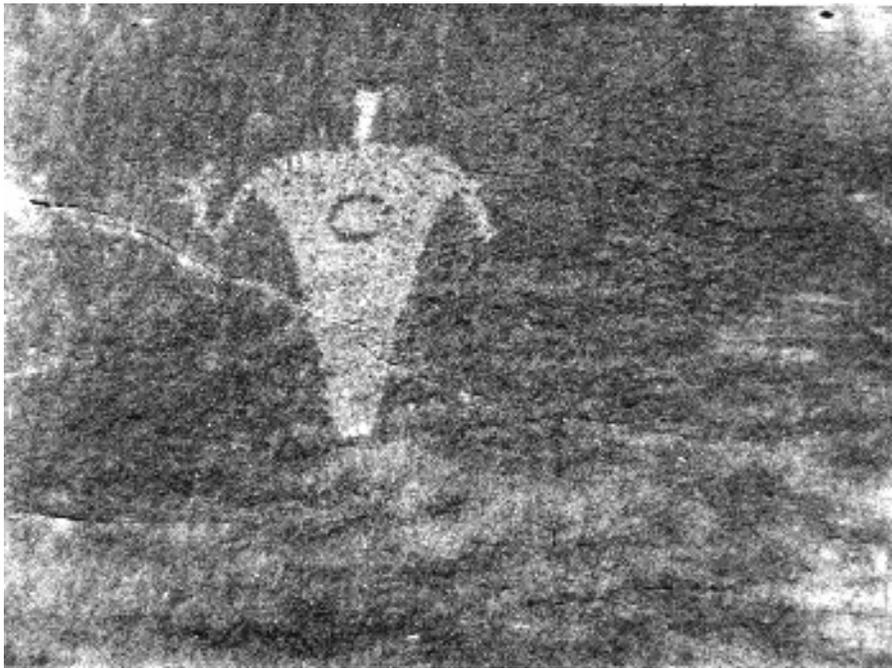
Figure 3.50: Rock art panel at 42Em2882 as observed in 1931 (Peabody Museum U-31-89).

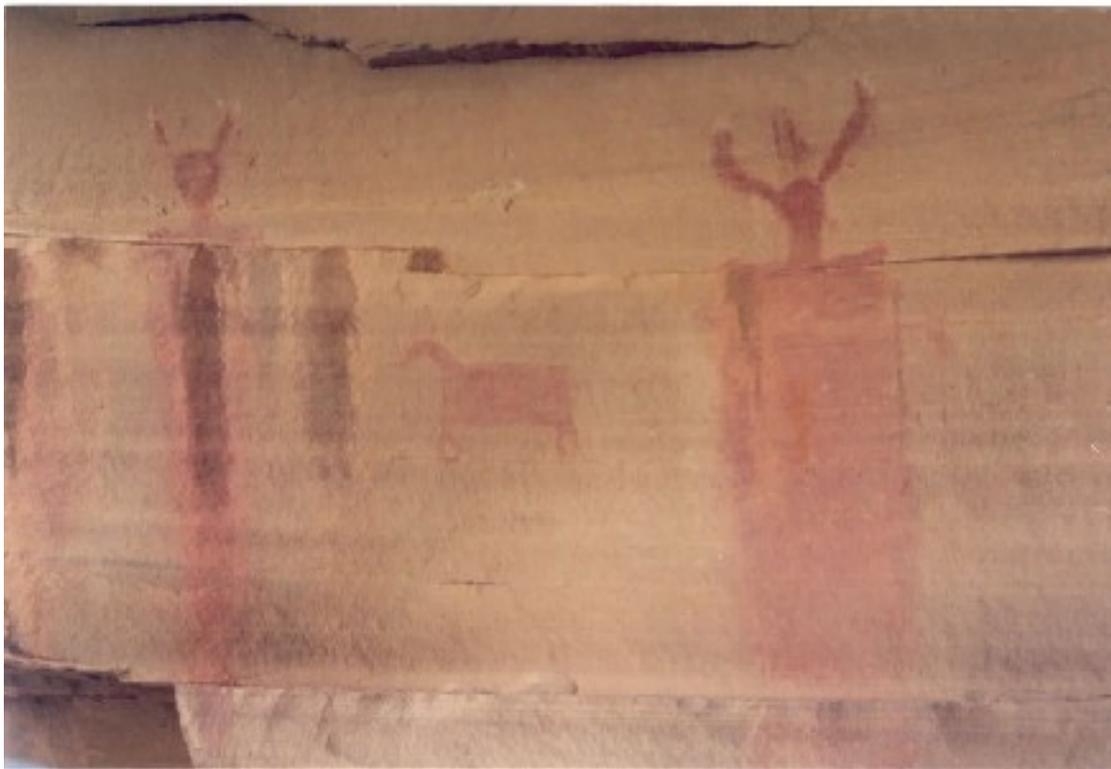
Figure 3.51: Rock art panel at 42Em2883 as observed in 2002 (J.D. Spangler).

The main rock art panel appears to be in essentially the same condition as that observed in 1931. However, the overall site has suffered extensively from adverse

impacts. Looters holes are evident in the deposits below the main rock art panel, and historic or modern images and initials have been scratched on the cliff face adjacent to the panel. Because this site remains among the most visited of any in the canyon, the resulting pedestrian traffic has resulted in a spider web of pedestrian trails lead up the talus slope to the site. These trails likely traverse extensive midden deposits. Two biface tools were observed on these trails during a 2005 site revisit, and lithic artifacts were eroding almost to the base of the slope. This site is located outside the south gate where public access is not restricted. It is recommended that this site be continually monitored for future adverse impacts, and that the land owner (BLM) establish a preferred pedestrian route to avoid potential damage to subsurface deposits or surface collection of eroding artifacts.

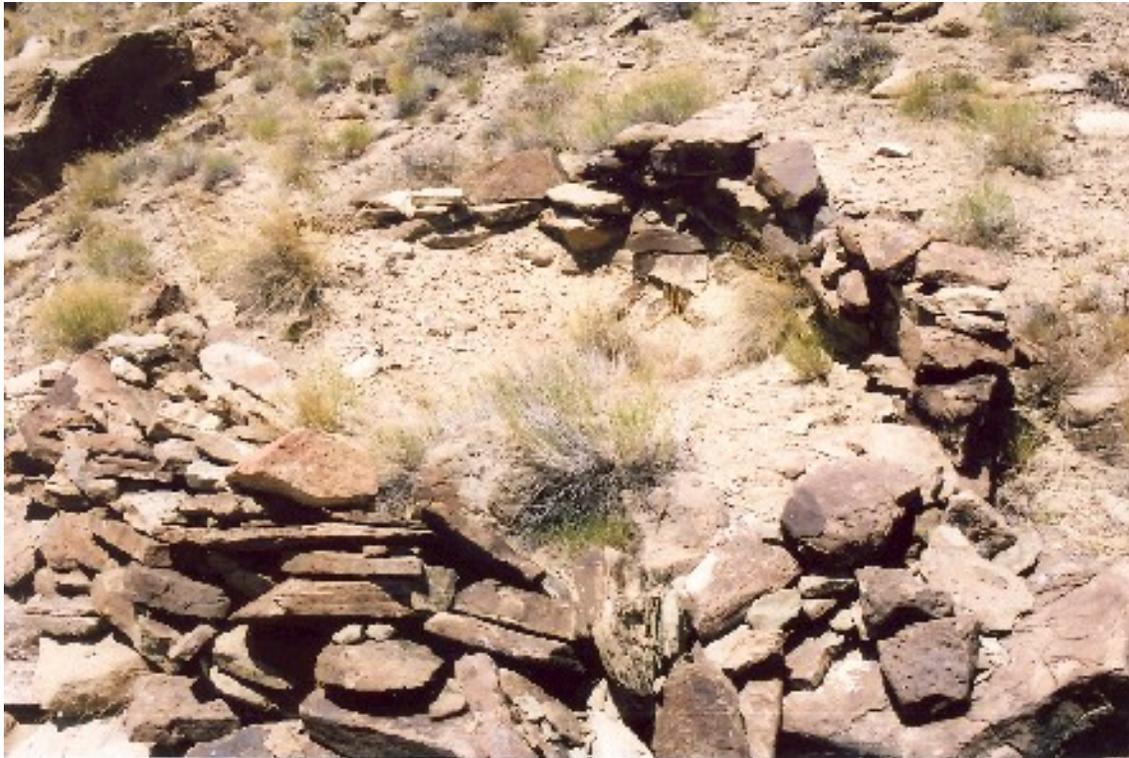
No photographic image was obtained from this site in 1931, and the written description was minimal. However, a close comparison of current site condition to the field notes indicates this site has been severely looted since that time. The interior deposits, described in 1931 as sandy with small stones and vegetation, has been removed by looters to a depth of 0.5 to 1 meter. It appears that wall stones have been restacked

(loosely) and the southwest doorway is no longer clearly delineated. Local informant Waldo Wilcox indicated this site, located adjacent to a natural gas well head, was vandalized in the mid-1960s by natural gas drilling crews stationed near there. It remains possible that small portions of the interior deposits remain intact, despite the extensive vandalism. The paucity of artifacts observed when the site was documented in 2002 was also observed upon its initial recording in 1931, and it is likely that few artifacts were ever present at this site. It is recommended that the BLM conduct consistent monitoring of this site for future adverse impacts.

Figure 3.54: Site 42Em754 as observed during 2006 site revisit (J.D. Spangler).

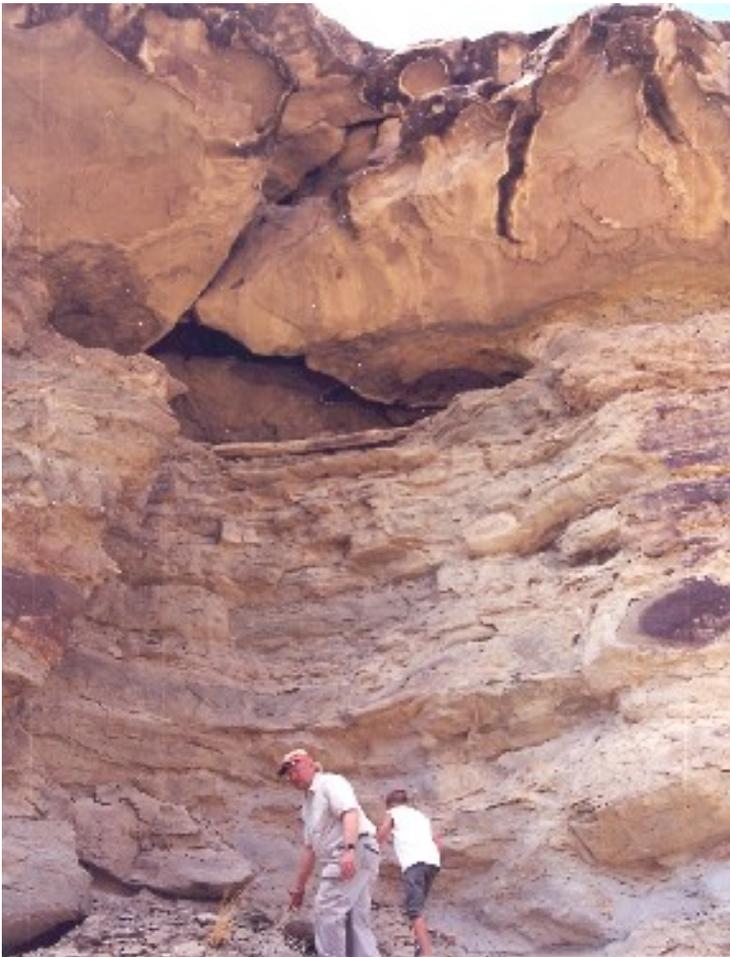
Access to this site was not possible, but observations from the slope below indicated the site has been severely damaged and that construction beams had been discarded over the edge. The site was initially described by Forbes as:

Figure 3.55: View of 42Em2891 from slope below (J.D. Spangler).

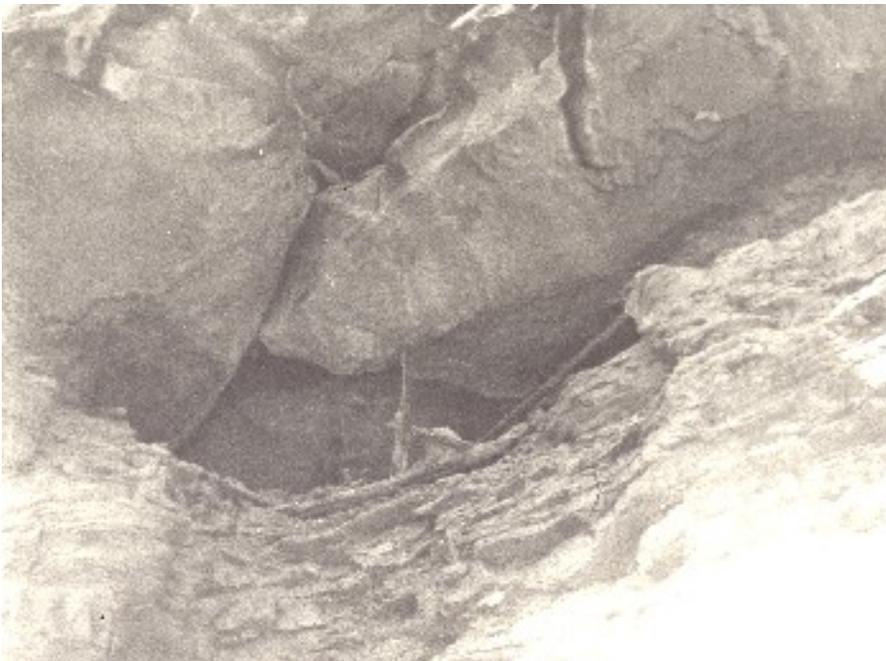
The 1931 photograph taken from the slope below (Figure 3.56) illustrates that additional construction poles were once part of the matrix. Furthermore, the description supports the existence of considerable building materials no longer visible inside the shelter. A recent side view into the sheltered area (Figure 3.57) reveals a paucity of structural materials remaining on the ledge, suggesting that destruction of this site since 1931 has been significant. Local informant Waldo Wilcox indicated this site, located near the natural gas well head, was vandalized by gas workers in the mid 1960s. Attempts to access this shelter from the northwest ledge, as described by Forbes, was not possible, suggesting the ledge providing access in the past has since eroded away. This site should be monitored for future adverse impacts, although the absence of easy access likely provides some level of protection. Given that cultural materials have been discarded from the shelter interior to the slope below where they are exposed to natural erosion, it is also recommended that data recovery be initiated in the slope area.

Figure 3.56: Site 42Em2891 as observed in 1931 (Peabody Museum U-31-745).

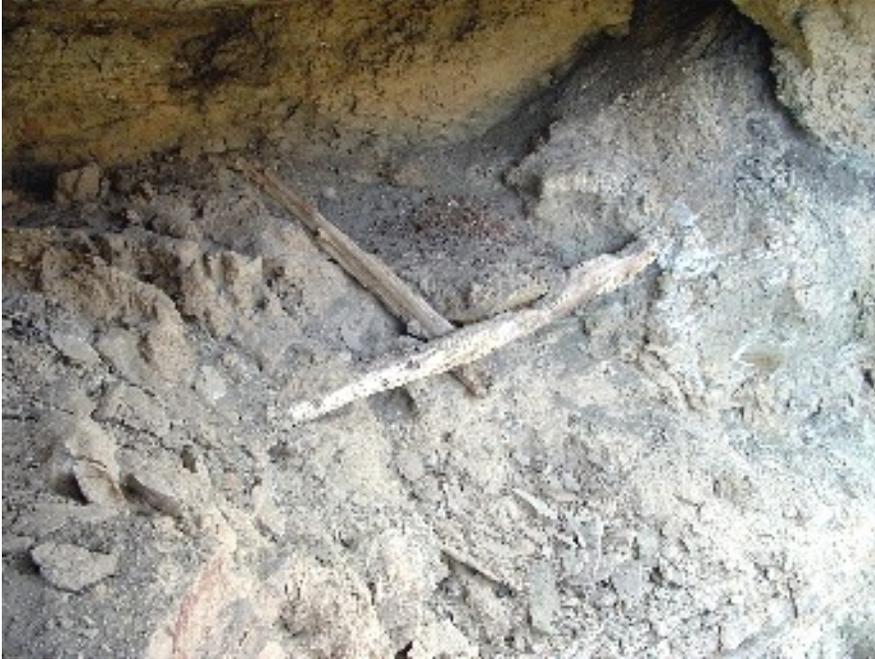
Figure 3.57: Side view into the interior of 42Em2891, as observed in 2006 (L. Coats)

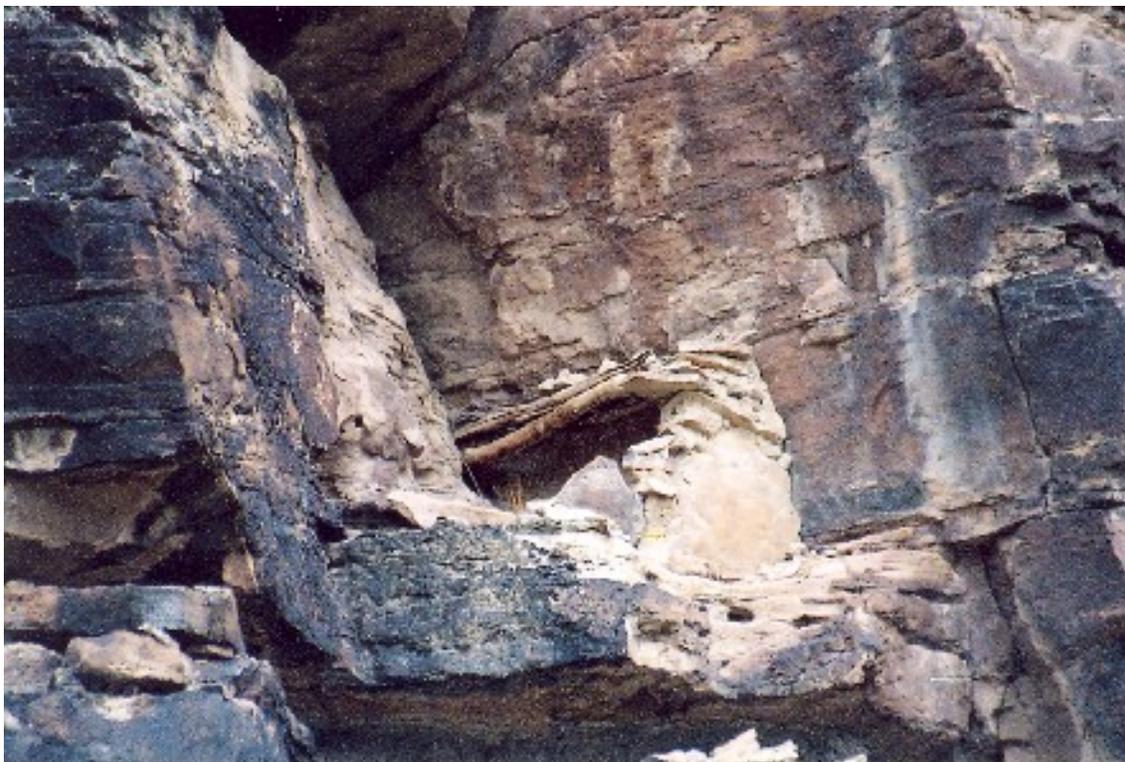
Figure 3.58: Site 42Em755 as observed in 2004 (J.D. Spangler).

An examination of the 1931 photograph (Figure 3.59) at this site does not reveal enough detail to allow an analysis. However, what is apparent is that a Clafin Emerson crew member was able to access the site, and that the front wall appears to have been intact at that time. This is further evidenced by Forbes's sketches of the interior of the feature (Figure 3.60). It is not known how the Clafin-Emerson crew obtained access to the site for the detailed descriptions. It appears the site has been damaged since 1931, with a portion of the front wall now missing. The 1931 sketches indicate these were intact at that time. It is possible this site has been vandalized despite its difficult access. Local informant Waldo Wilcox indicated that two "squatters" once set up a trailer house in that locality and remained there for two years, vandalizing sites and searching for artifacts. It is unknown to what extent interior deposits and features have been damaged. The extremely difficult access to this site, located on state lands, likely provides some level of protection from adverse human impacts in the future. It is recommended that SITLA monitor this site for future impacts.

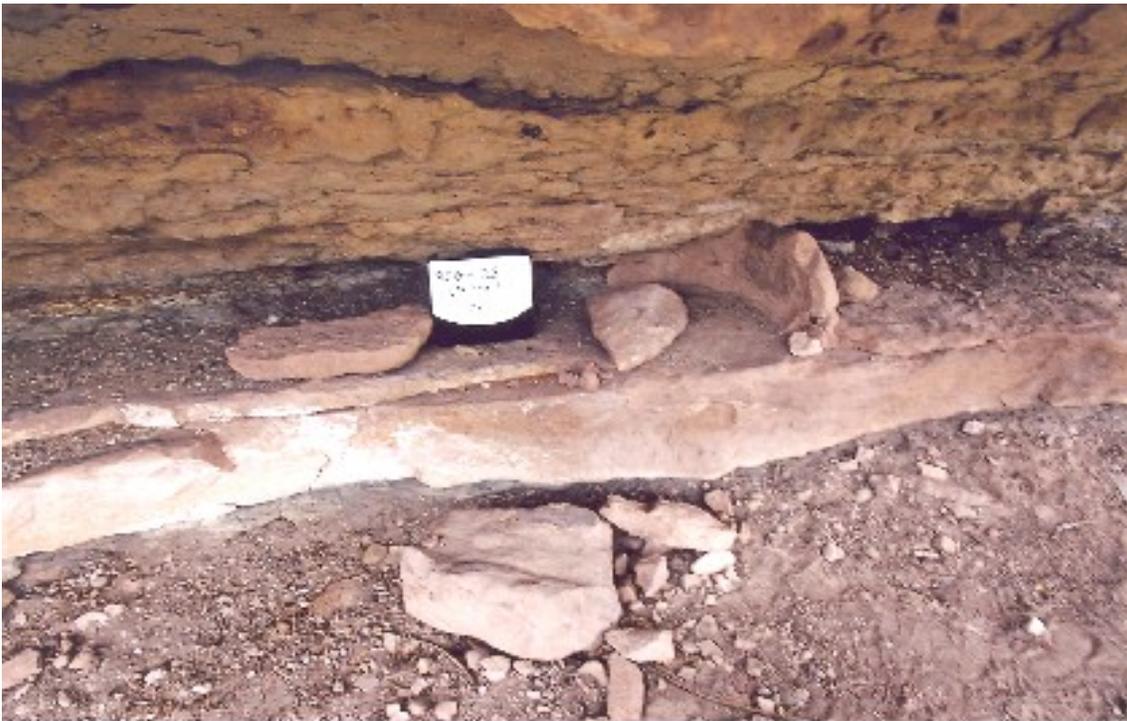
Figure 3.61: View of remnants of a granary feature at 42Em756, as observed in 2004 (J.D. Spangler).

The field notes indicate a photograph was taken (U31-88), but this photo was not identified in the Peabody Museum archives. Most of what the 1931 expedition described has been badly vandalized and little remains intact to offer a comparison to earlier observations. Two features described in 1931 are still evident: a granary tucked against the rear wall of the shelter and a pile of stones near the south wall of the structure. Looting also exposed additional features not evident in 1931. As with nearby 42Em755, local informant Waldo Wilcox indicated that two “squatters” once set up a trailer house in this area and remained there for two years, vandalizing sites. This site, located on lands managed by SITLA, is located about 5 kilometers south of the south locked gate in an

area of unrestricted public access, and the relatively easy access makes it susceptible to future vandalism. It is recommended that SITLA not disclose this site location and that it monitor the site for future impacts.

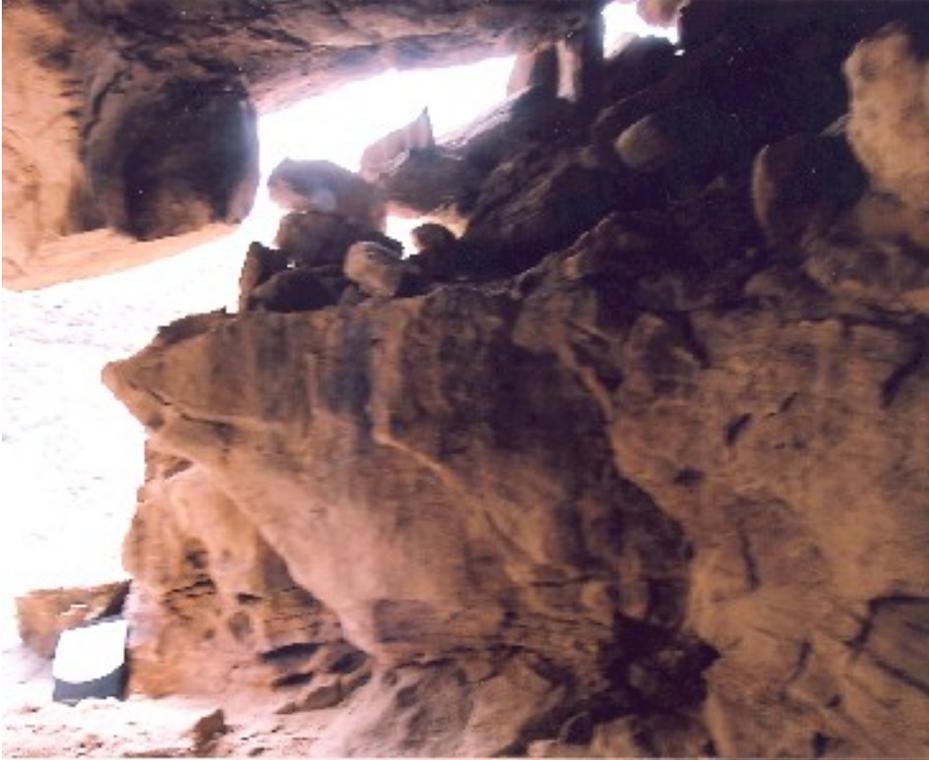
[REDACTED]. Stone slabs and blocks have been roughly stacked into a drylaid masonry wall along the west side of the shelter, inhibiting access to the shelter. The wall measures 4 meters long and up to 87 centimeters high. Evidence of a looters pit was identified in the center of the shelter with back-piles displaced to the front of the shelter. It was initially described by Forbes as:

Figure 3.64: Drylaid stone wall at 42Em759, as observed in 2004 (J.D. Spangler).

The site was relocated and documented in 2004 and was found to be in good condition despite the vandalism. A large corrugated potsherd was collected in 2004 that was not mentioned in the 1931 notes, suggesting the potential for subsurface deposits that may not have been disturbed by the vandalism. This site is easily accessible from the Range Creek road and likely receives some visitation. It is recommended that SITLA monitor this site for future adverse human impacts.

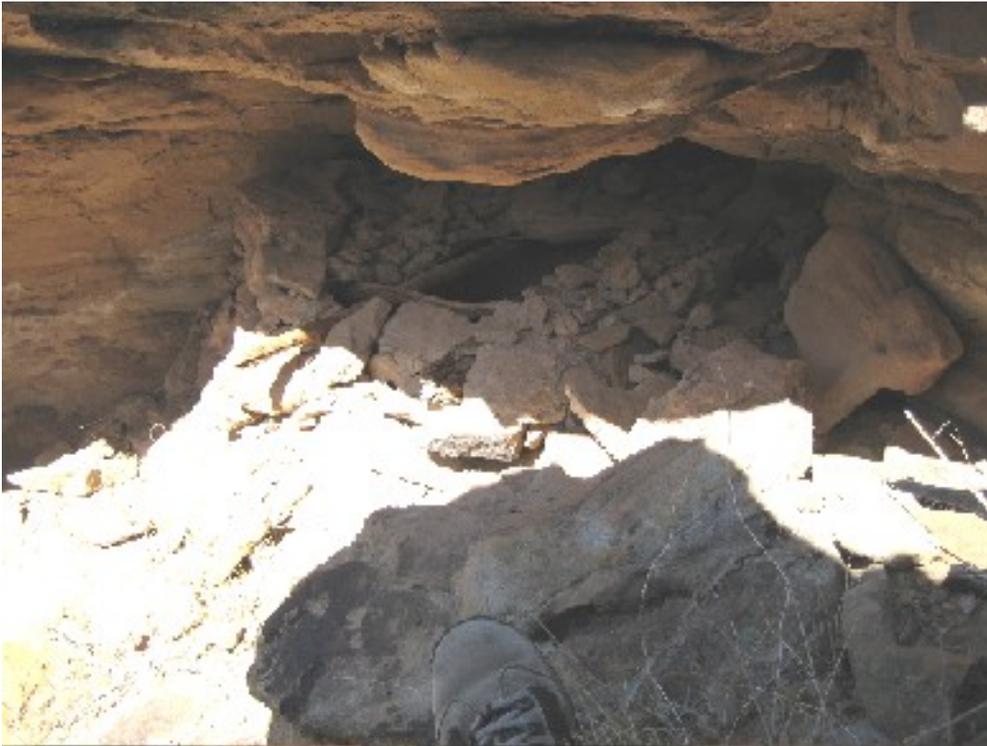
The Claflin-Emerson field notes indicate four photographs were taken of this lower granary, but perhaps only two appear to be applicable to this feature. One photograph (Figure 3.69) is a lateral view of the camouflaged storage unit with an intact superstructure, and the other photograph is a close-up view of a superstructure with vegetal bindings in place (Figure 3.70). These bindings are also illustrated by Bowers (1931:29). These photographs graphically illustrate the pristine condition of the feature. Given the current condition (Figure 3.71), it appears the lower granary has been partially dismantled and construction materials removed from the front of the structure.

Figure 3.71: View of lower granary in 2006 (K.R. Barlow, courtesy of the National Geographic Society Committee for Research and Exploration).

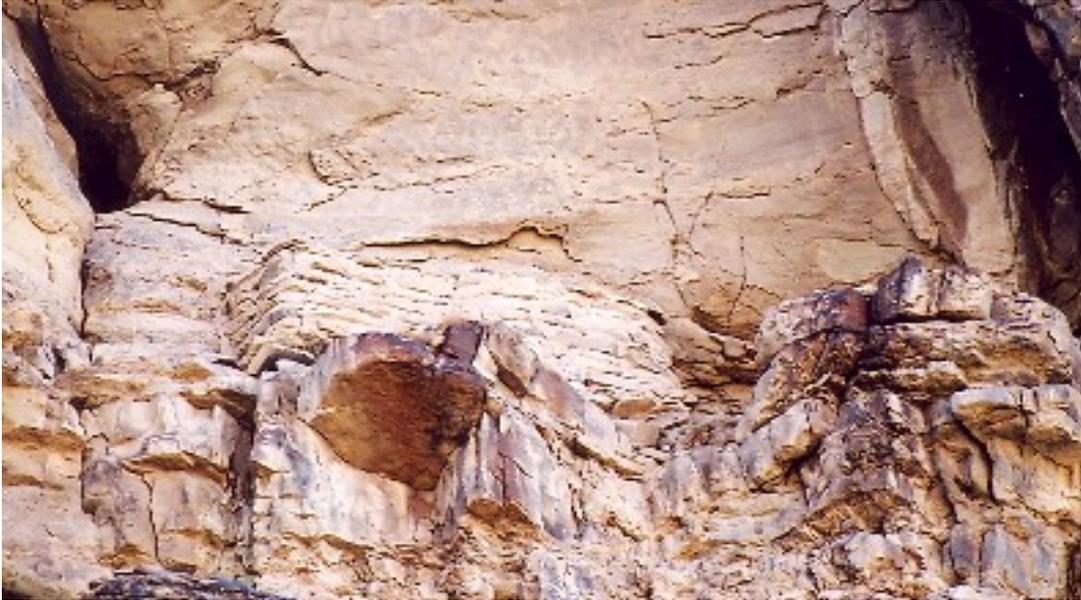
The upper granaries, when observed from the valley floor in 2004, appeared to be in pristine condition (Figure 3.73). The 1931 photographs depict the exceptional exterior wall construction (Figure 3.74), and of the roof matrix that included a round stone lid (Figure 3.75). Upon revisiting this site in 2006, it was determined that the site has been impacted, probably from human visitation despite its difficult access. The stone lid is no longer evidence at the site, and the vegetal matrix is not as evident now as it was in 1931 (Figure 3.76). However, the exterior wall condition appears to intact and unchanged from that depicted in the 1931 photograph (Figure 3.77). The difficult access to these structures has likely contributed to their good structural integrity and may have preserved interior deposits. Given that individuals have found a way to access this site in the past, it is recommended the BLM monitor this site for future impacts.

Figure 3.72: View of upper granaries at 42Em761, as observed in 2004 from valley floor (J.D. Spangler).

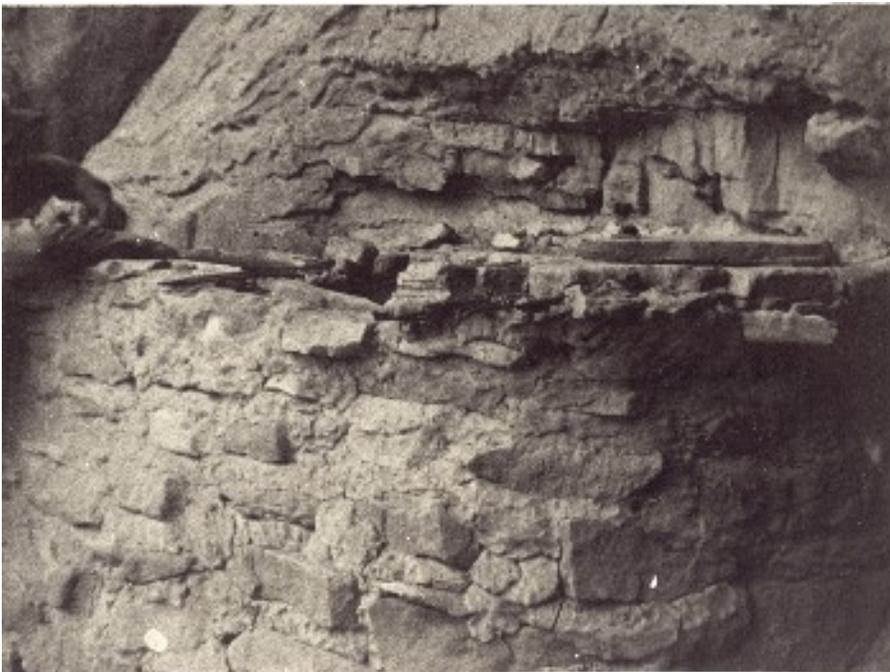
Figure 3.73: Exterior wall construction at 42Em761, as observed in 1931 (Peabody Museum U-31-84).

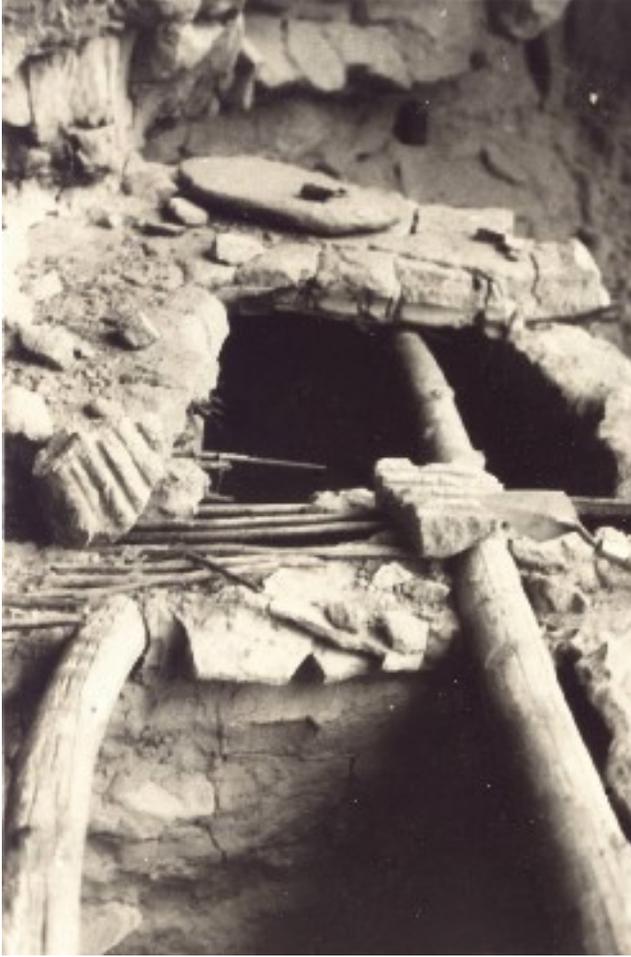
Figure 3.74: Roof of upper granaries at 42Em761, as observed in 1931 (Peabody Museum U-31-294).
